Summary of Activities

Date: July 28, 2016

Subject: Chain Lakes - Bathmetry & Water Level Investigations

Location: Chain Lakes, Duck Mountains, MB - 14 U 368079 5726194

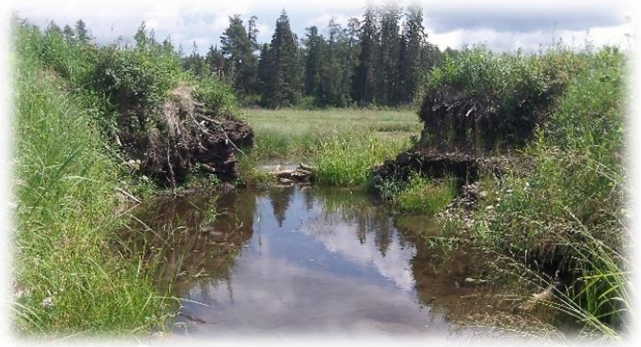
Recommendations: Due to observations and information collected on July 16th, it is without a doubt that the lake levels are significantly lower, and the root cause of this has been identified. A large dam on the far north of the "chains" has blown and as a result dropped water levels significantly (especially in the lower reaches ~2m). After discussions with local, and common Chain Lakes anglers we have determined that this drop in water levels likely occurred at some point between 2014 and 2015. At this point in time, we see no immediate need for dam rehabilitation, as it appears that each reach of the chain lake system currently possesses enough depth to support northern pike populations. However, if it becomes necessary to initiate dam rehabilitation in the future, the route cause has been identified.

Fig: Blown Dam - North End

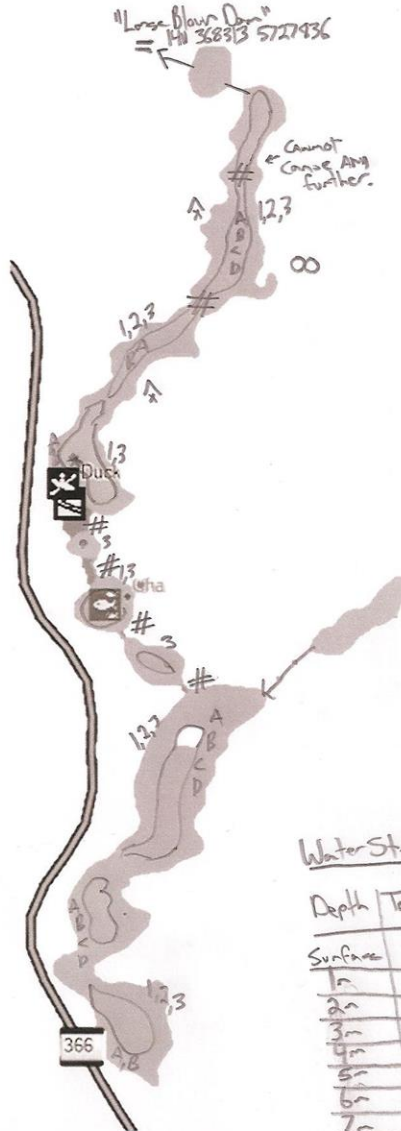
CHAIN LAKES Habitat, Water Sampling & General Observations.

- Water flows from South-North
- First passage thru "chains" would be possible during high water or in spring.
- Water Levels appear slightly low in all chains, until the chain w/ the 9m hole, where levels appear to be ~2m below normal & chains north of here appear very low as well.
- Observed Northern Pike & Yellow perch in all reaches of the system.
- Loose Dam on north end has blown and appears to be reason why decline in water levels.
- Yoy NRPK noted in smaller central chains and likely serve as nursery waters.
- Large schools of YLPR observed throughout system.
