# STREAM ANALYSIS AND FISH HABITAT DESIGN

*A Field Manual*

# **Design and Construction of Stream Habitat Works**

## Design Example 4: North Pine River Trout Habitat Enhancement

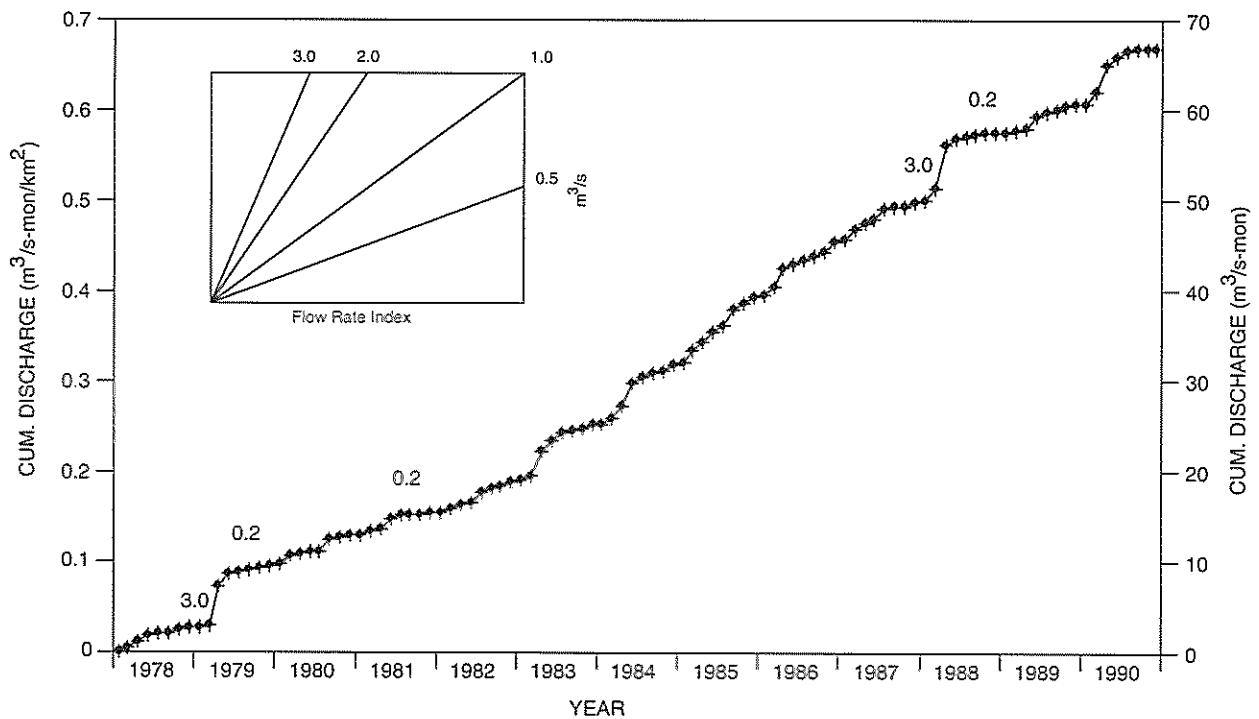
Figure 4-39: Mass curve of monthly flows for the North Pine River 1978-1990.

The mass curve of monthly flows for the North Pine site is shown in Figure 4-39. The flows are steady in the open-water season because of natural regulation by upstream storage in small lakes and marshes on the top of the escarpment. The average monthly flow for the open water season in the 1978-1990 period was 0.6 m<sup>3</sup>/s. The lowest monthly mid-summer flows were maintained at 0.2 m<sup>3</sup>/s and Spring runoff flows did not exceed 3 m<sup>3</sup>/s. The lowest flow period occurs in mid-winter. During this period, resident fish populations have been observed in beaver ponds above and below the North Pine site. Open water is maintained only in reaches with inflowing groundwater. This condition occurs in the upper half of the North Pine site.

The existing naturally regulated flow regime of the Pine River (Figure 4-39) presently supports the resident trout population and requires no augmentation (discussed in Section 3). In low-flow years the excavated pools in the meandering reach would decrease to an average depth of 0.6 m. Assuming the beaver population will not be

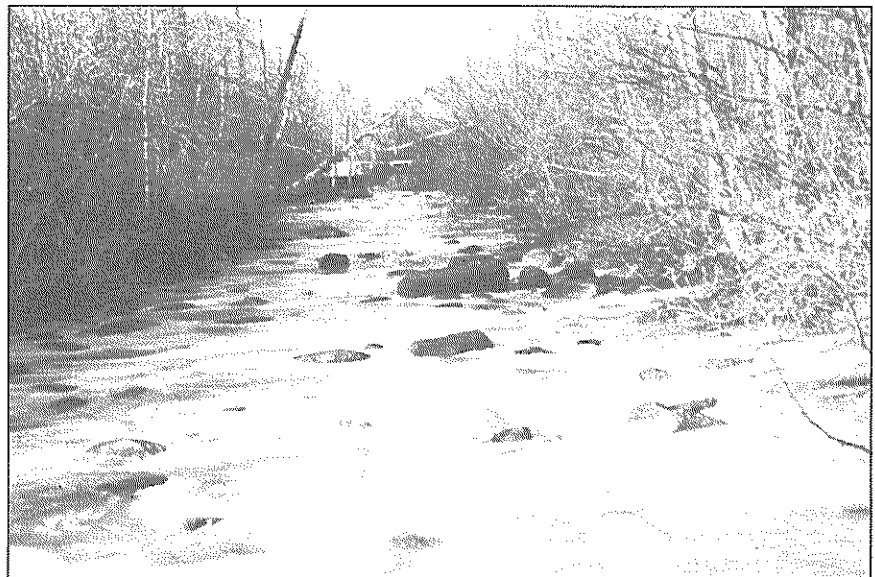
**Figure 4-40:** The uniform straight channel of the North Pine enhancement reach prior to construction. A highway bridge is located in the middle of the reach.

The North Pine survey reach and a similar straight segment of the stream above the Beaver Lake Provincial Road crossing was used for the experimental trout habitat meander project. The natural reach prior to construction is shown in Figure 4-40. The plan and profile of the project reaches are shown in the upper diagram in Figure 4-41.

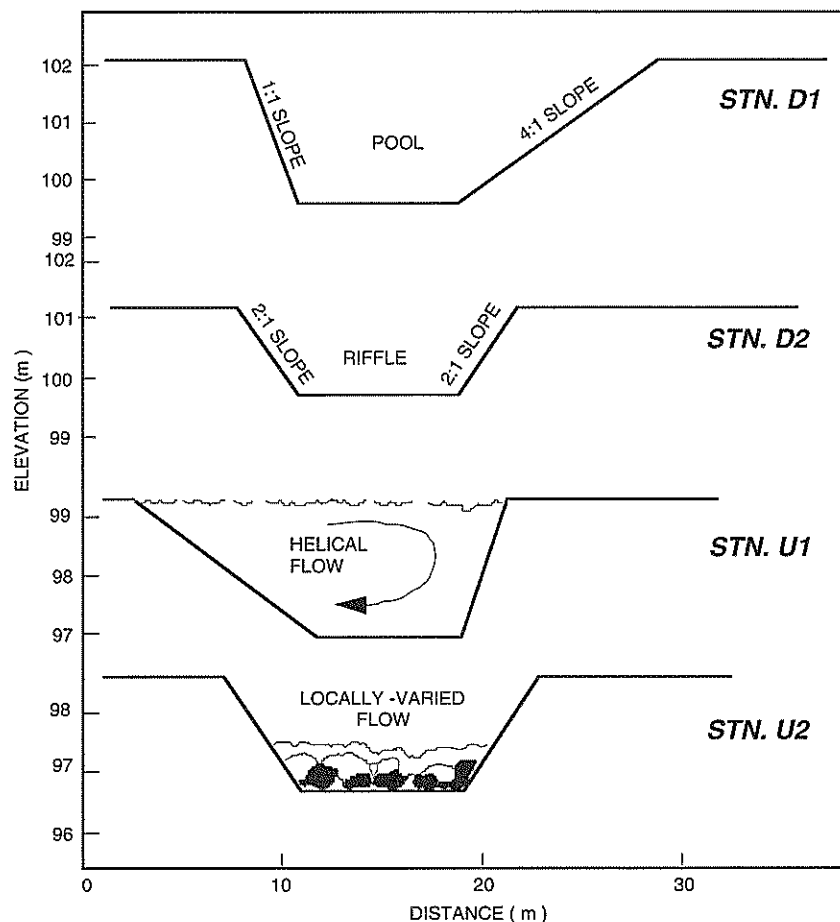
**Figure 4-42:** Variation in excavated cross-sections through the excavated meanders in the North Pine River project.

The natural straight channel was stable at the estimated bankfull flow of  $6.7 \text{ m}^3/\text{s}$ . The constructed meanders in the stream segment decreased the average slope in the reach from .022 to .018, increasing the stability even further. The local slope of the riffle sections was not changed but the average size of the bed paving materials was increased by adding spaced boulders to create aeration zones and diverse local flow conditions.

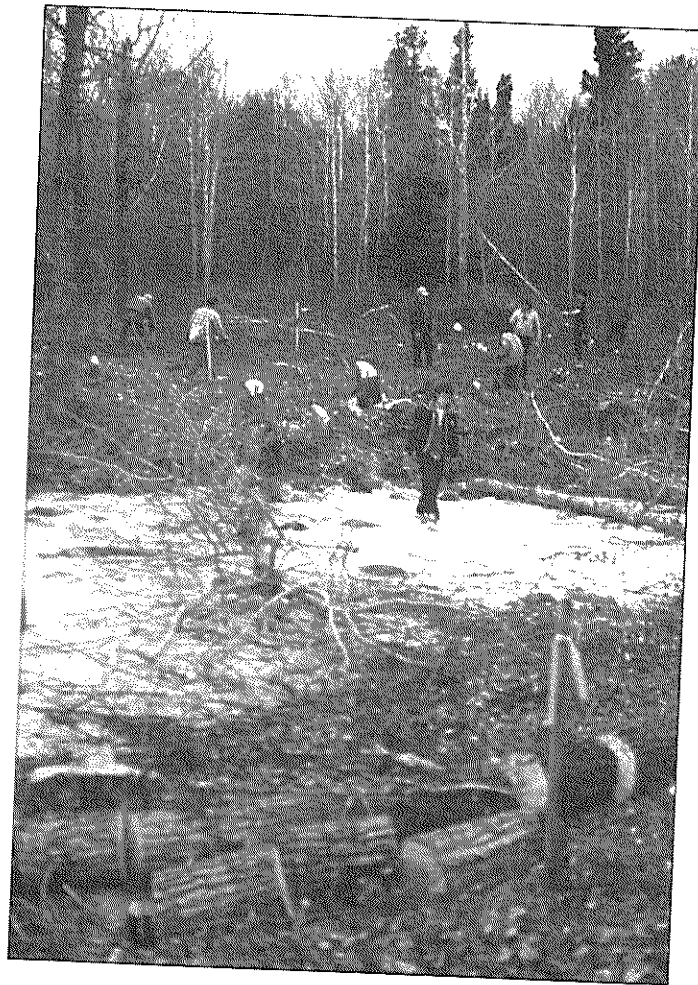
**Figure 4-43:** Volunteers clearing the meander path as it crosses the original channel of the North Pine enhancement reach.

The alignment of the new meandering channel was established by measuring offsets from the centre of the existing channel. The tops of the channel banks were marked with survey stakes, allowing for an 8 m base and varying side slopes. The meander path was then cleared by hand by members of the Swan Valley Sport Fishing Enhancement group and students of the Swan Valley Regional High School (Figure 4-43).

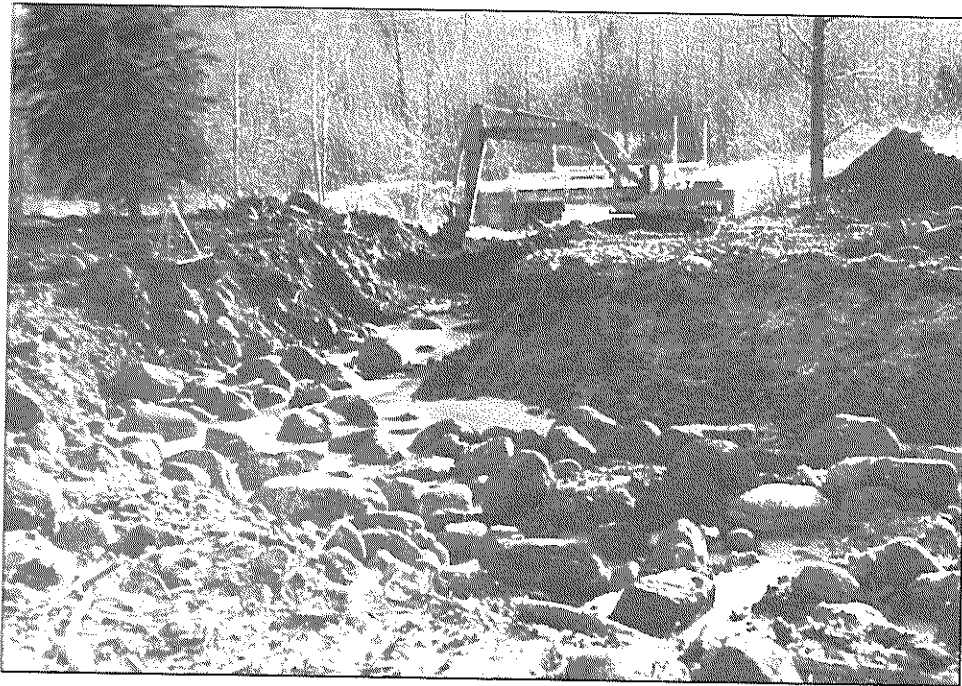
**Figure 4-44:**  
Excavation of the first  
upstream meander  
bend above the  
highway bridge in the  
North Pine project  
(Figure 4-40 shows the  
pre-excavation  
channel).

The channel was excavated with an 0.5 m<sup>3</sup> bucket track-mounted backhoe assisted with a small bulldozer to infill the old channel (Figure 4-44).

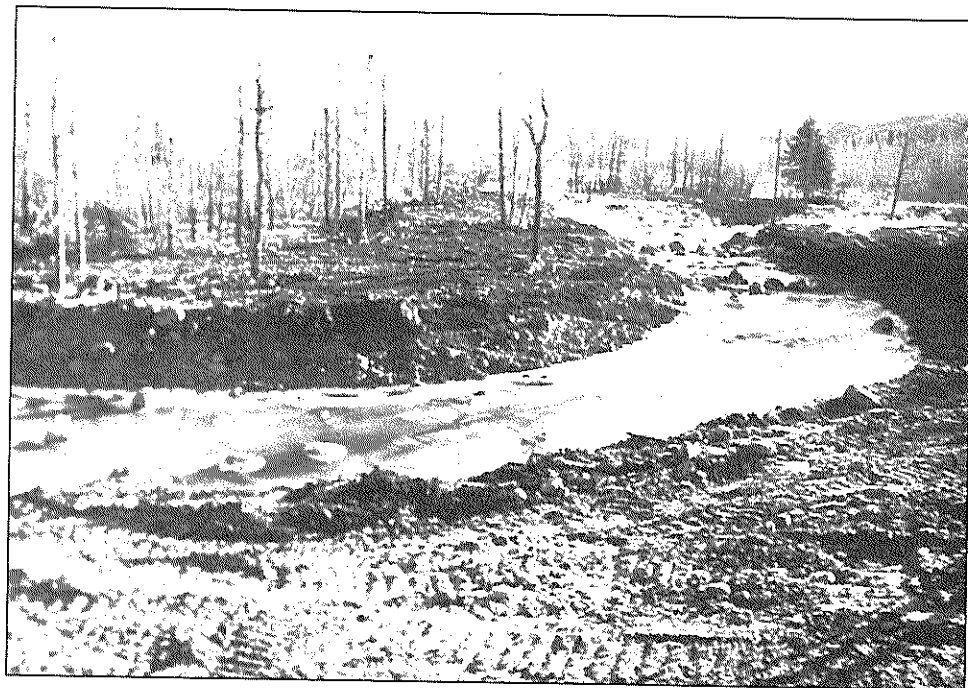
**Figure 4-45:** The  
completed upstream  
meander bend of the  
North Pine River trout  
habitat enhancement  
project (December  
1990).

Where possible, existing trees along the new course of the channel were saved, particularly on the outside of the meander bends to provide cover over the newly excavated pools. The completed meander upstream from the highway bridge is shown in Figure 4-45. In 1991, the project reach was re-planted with local trees and shrubs by volunteers from the Swan Valley Regional High School.

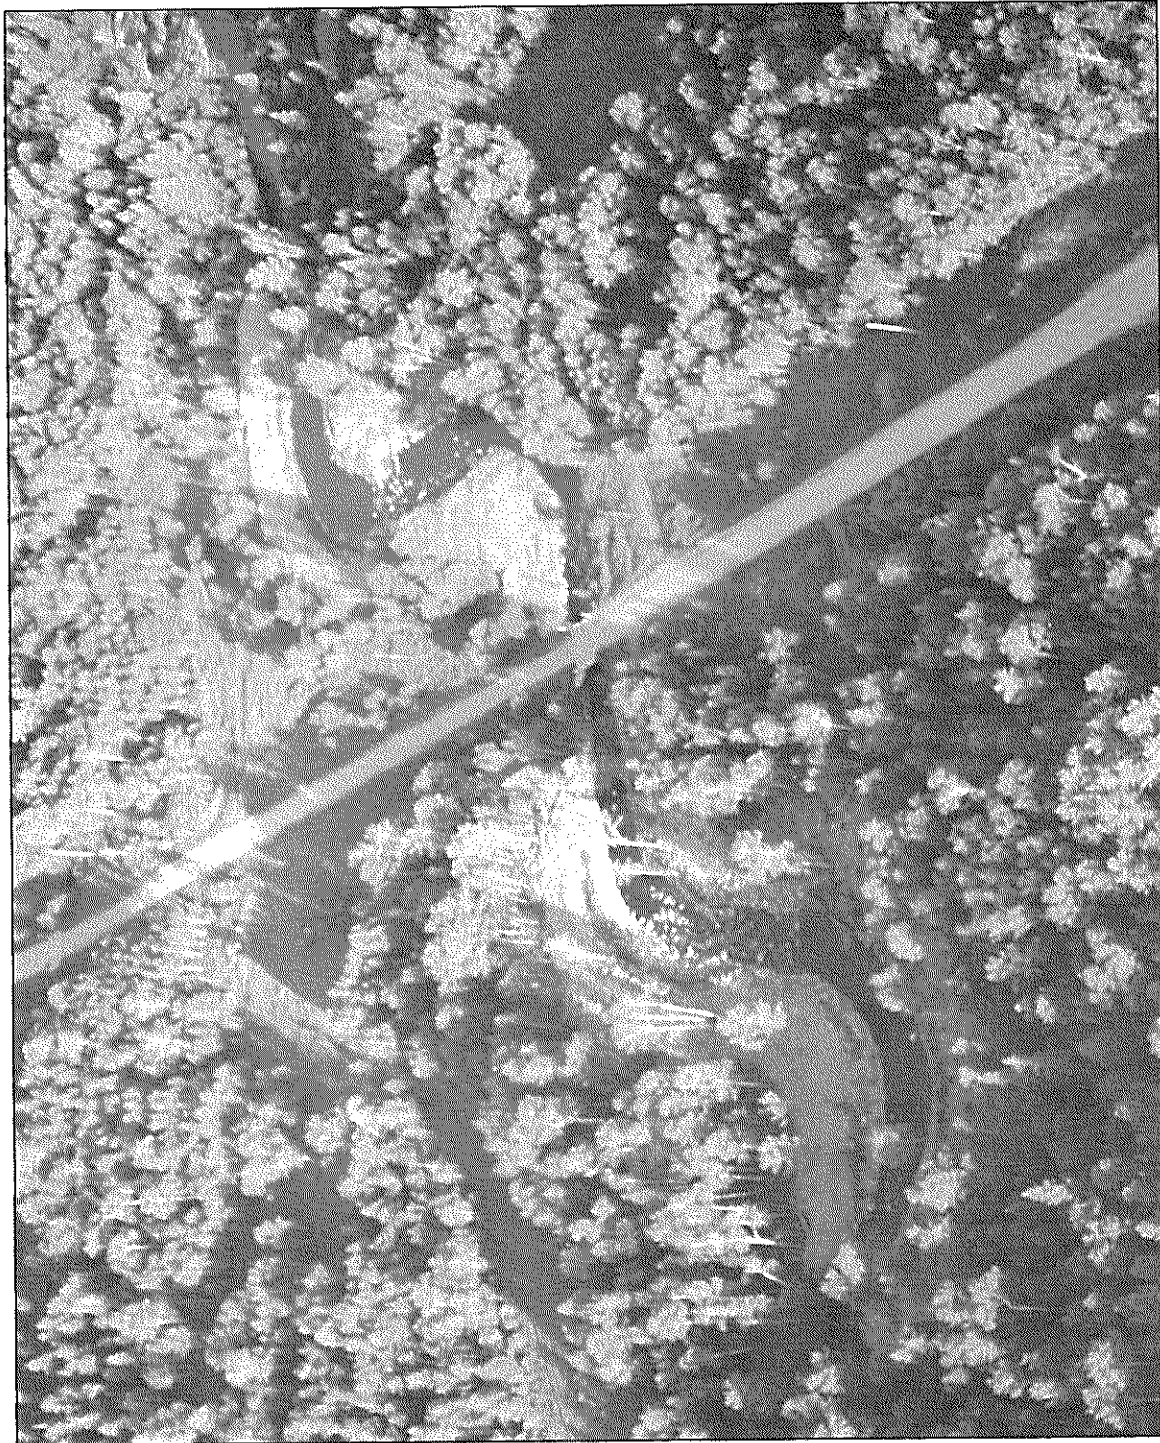
**Figure 4-46:** Aerial view of the North Pine River trout habitat enhancement reach. The meandering channel mimics successful trout angling reaches surveyed on the lower Pine River and adjacent streams.

In 1991, a moderate spring flood peak was observed at the Pine River gauging station of 5.74 m<sup>3</sup>/s, equivalent to an annual flood peak frequency of 92 % (Figure 3-3). The flood peak in the excavated meandering reach was estimated to be 3 m<sup>3</sup>/s. Following the peak, a small delta of coarse sands was observed in the upper pools. There was no movement of the cobbles and boulders in the riffle zones. Trout were observed and caught in the project reach in the 1991 open-water season. An aerial view of the excavated meanders under low flow conditions following the first flood peak is shown in Figure 4-46.
