# **FISH AND HABITAT SURVEY:** **WHITEFISH LAKE TRIBUTARIES**

**June to October 2009**

**SWAN VALLEY SPORTFISHING  
ENHANCEMENT CORPORATION**

M. Lowdon  
AAE Tech Services Inc.  
119 Woodchester Bay  
Winnipeg, MB R3R 3E5

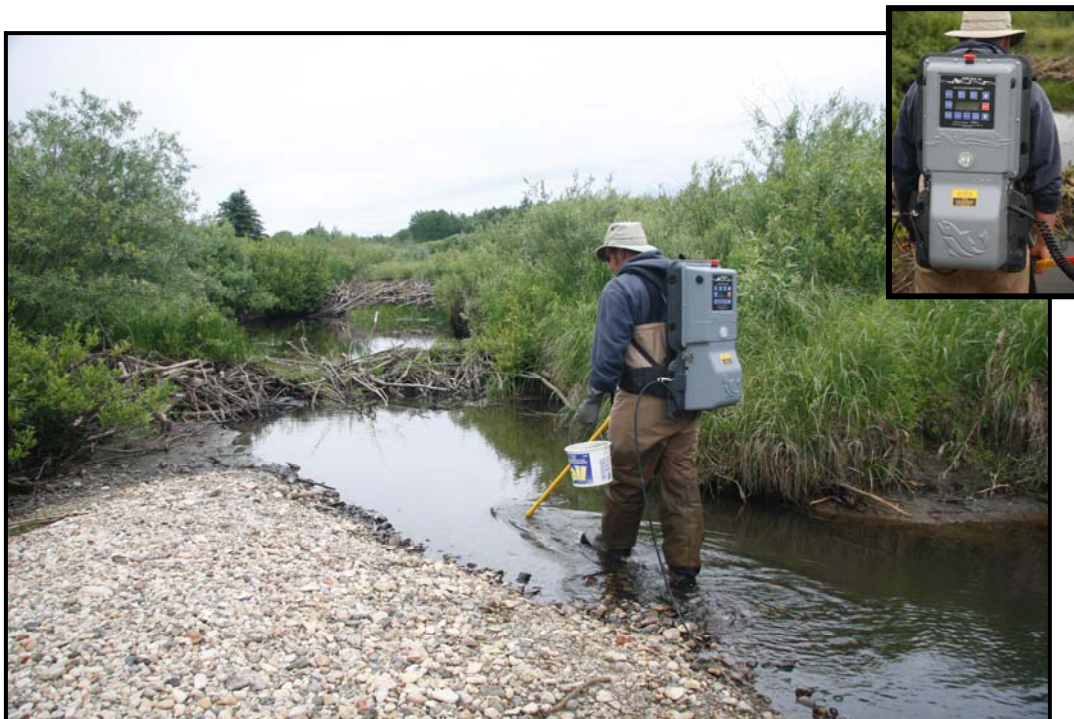
Backpack electrofishing (Smith-Root Model LR24) was the primary method used to assess the fish community within North Creek during the summer and fall of 2009. Electrofishing was conducted at various locations within the first 1.5 km of creek during the summer months. During the fall, sampling was conducted within one reach approximately 4.0 kilometers upstream of Whitefish Lake. Fish captured were identified, had their fork length measured, and were released live. Some voucher specimens of each species captured were preserved in 10% formalin to verify species identification. Digital photographs were also taken of representative specimens.

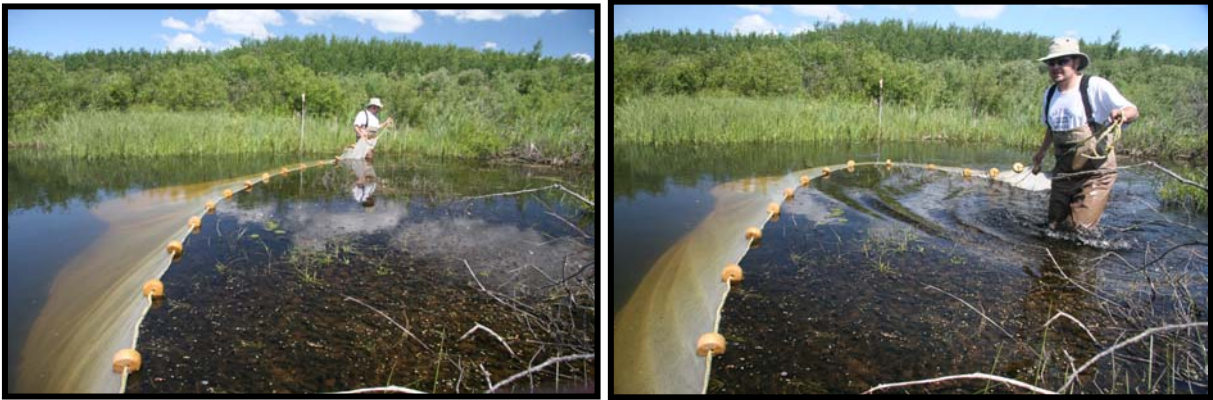
Seining was the most effective methodology used to capture fish within Lagoon Creek. However, due to high water levels, sampling was limited to those areas where wading was possible, or where a boat seining could be done safely. The seine net used was 10 m long (30 feet) and 1.8 m deep (6 feet), composed on nylon fabric with mesh size of 1/16 inch ace netting. To capture fish, one end of the net was held in place at a fix location. The other end of the net was swung over the sampled area as shown in the illustration below. Fish captured within the net were enumerated, identified and released unharmed. Voucher specimens for each species captured were photographed and preserved in 10% formalin. A sub-sample also had their fork lengths (FL) measured.

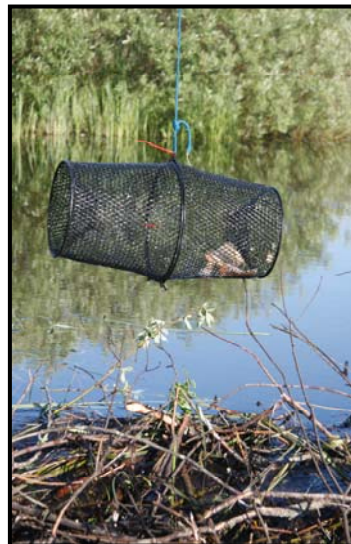
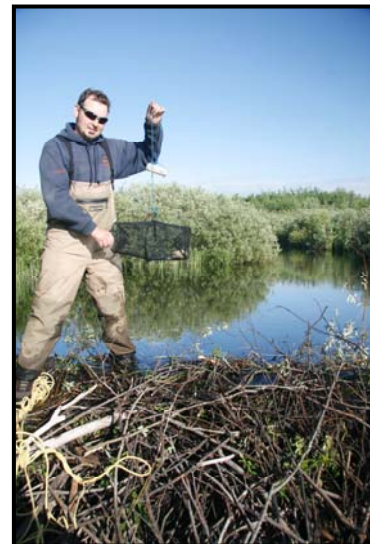
Gee Minnow Traps

Five minnow traps were also placed at various locations within each tributary during the summer of 2009. Each trap was baited with bread to entice fish into the traps. The traps were set for approximately 24 hours, lifted, and then re-set for an additional 24-hour period at another sampling location. The traps were evenly distributed over each creek. All traps were set in water depths ranging from 0.40 to 1.5 m. Sample locations were recorded using a Garmin GPS unit. Minnow traps were not set during the fall due to poor results obtained during the summer sampling period.

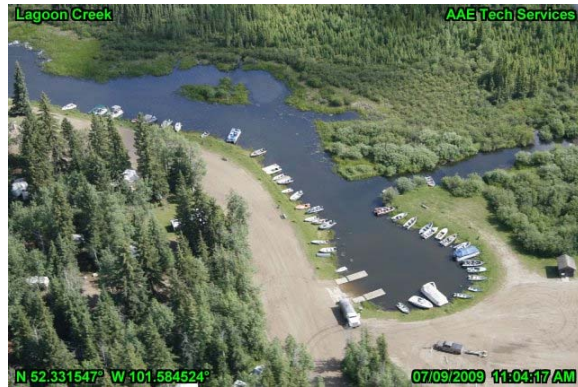
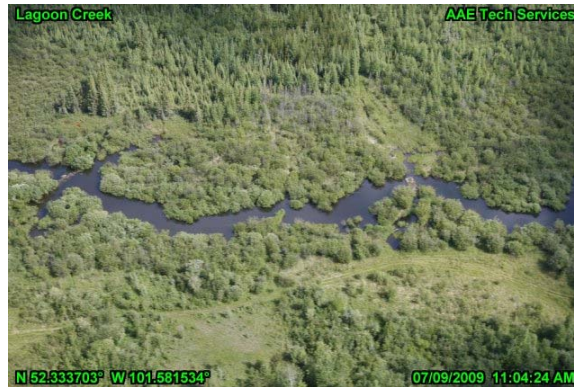
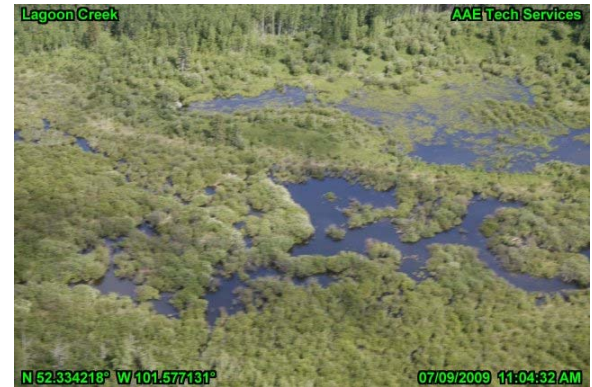
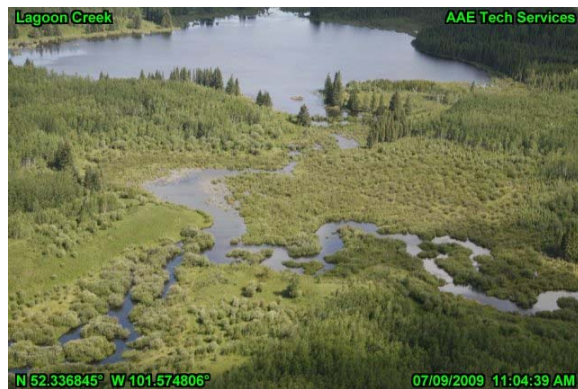
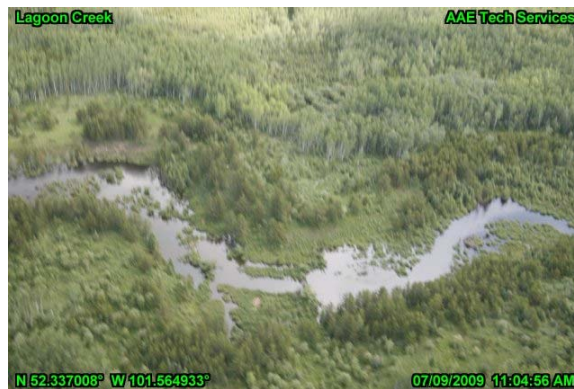
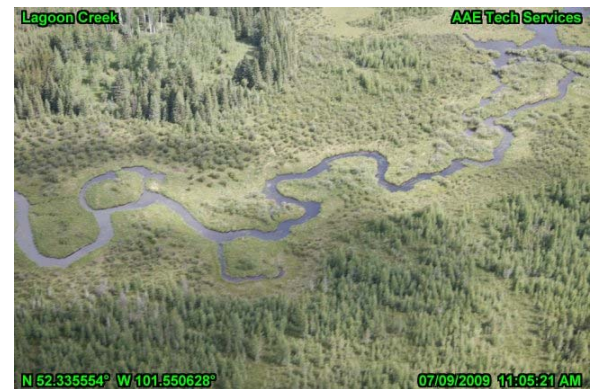
**Figure 3. Lagoon Creek Aerial Photographs**

Aerial photographs taken while conducting this project are displayed within three different sections of the report. In Figures 3 and 4, representative aerial photographs are displayed for both Lagoon Creek and North Creek respectively. These photographs were captured at an altitude of approximately 500 feet. The entire lengths of each tributary are also displayed in Appendix A and B for Lagoon Creek and North Creek respectively. All the digital photographs were pieced together to make it easy to visualize the types of habitats and barriers found within each of the tributaries examined. Within the overview of each creek, potential barriers to fish movement and the sampling locations are displayed. Finally, all the aerial photographs taken for both creeks and time periods can be found on the attached cd. All photographs are organized and separated into folders, identified by the creek name and flight date. In addition, files compatible with MapSource and ArcView, are included on the cd. The MapSource and ArcView files allow one to display the flight path and location of the individual photographs.

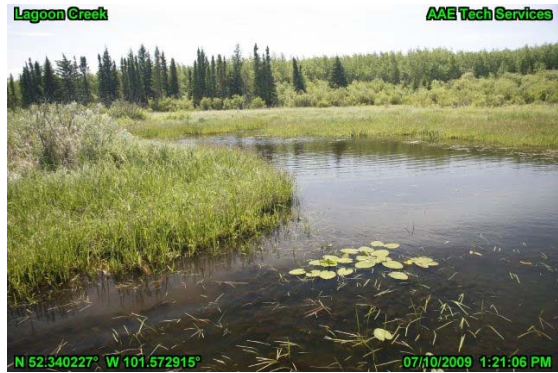
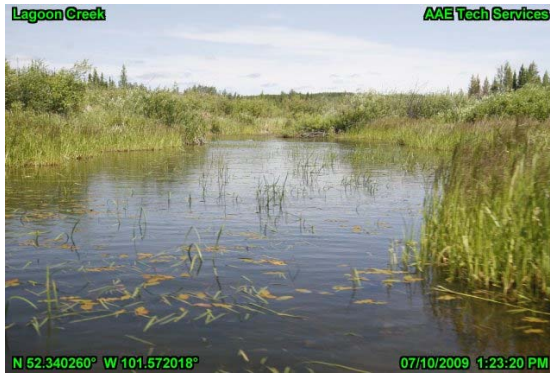
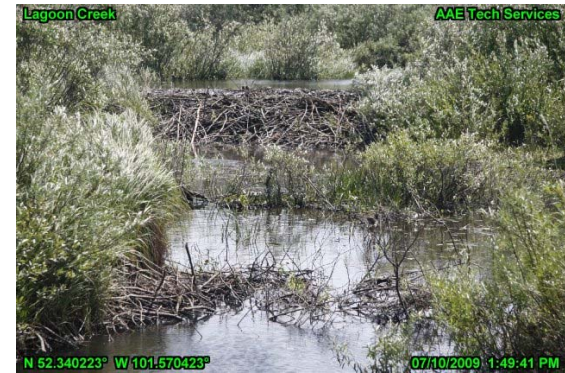
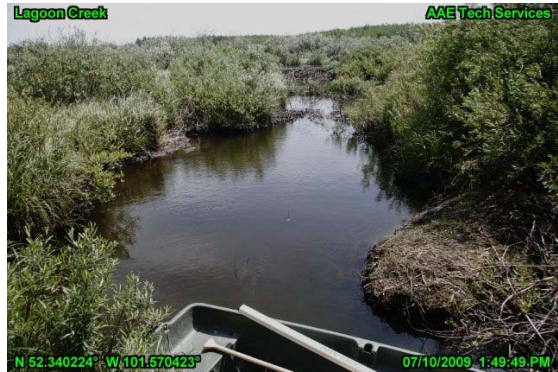
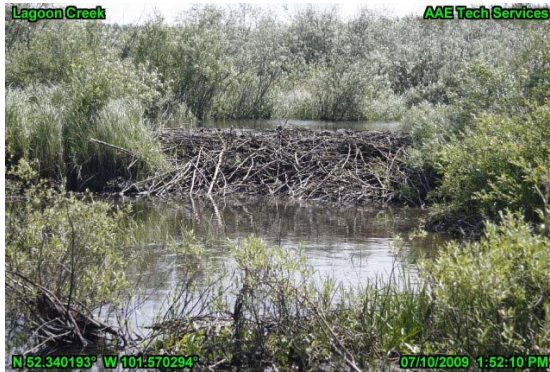
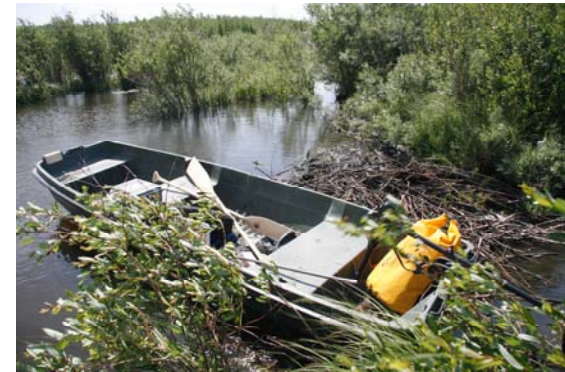
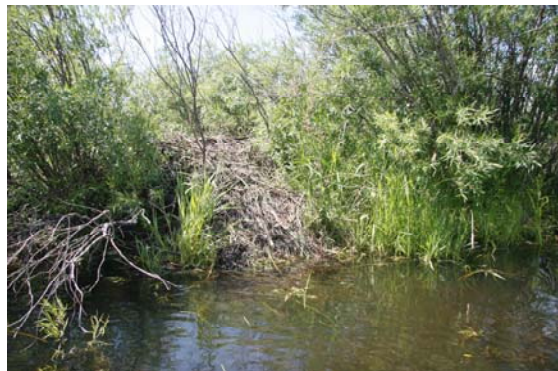
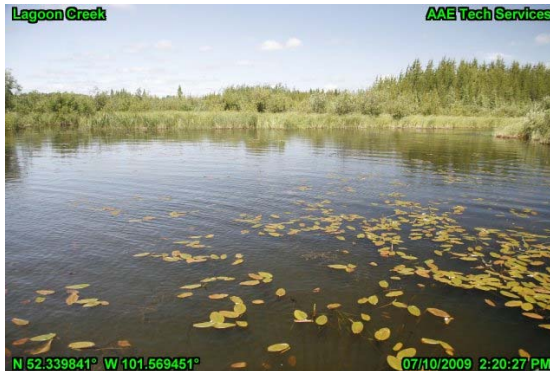
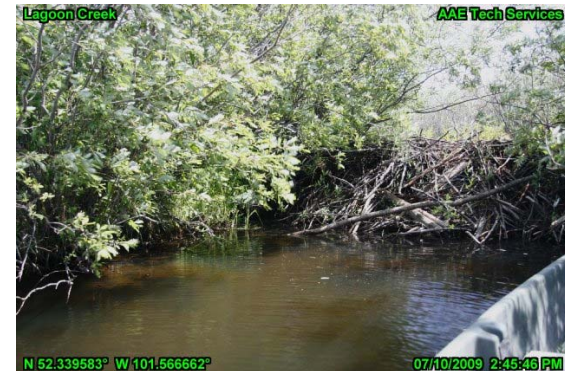
**Figure 5. Lagoon Creek Ground Photographs**

Photographs of the habitat within each creek are displayed on Figures 5 and 6 for Lagoon Creek and North Creek respectively. Similar to the aerial photographs, the ground truthing photographs can all be found on the attached cd.

Bed paving materials were documented during field surveys and with the use of the aerial photography. Silt and fine particles made up the majority of the substrates observed within Lagoon Creek. Larger particles (boulders/cobble), although not observed within the lower reaches (5 km) of the creek, were identified at a few upstream locations (Appendix A). Gravel was also rare, only being observed at a few beaver dam locations within the lower sections of the creek. Water depths greater than 1.0 m made it difficult to visually inspect the substrate types using the aerial photographs. It was also difficult to identify all the substrate types found within the creek as more coarse substrates (gravel, cobble, boulder) were most often covered with finer materials. With the removal of the beaver dams within the creek, finer sediments would likely be swept clean within the main channel during high flow conditions, i.e. spring runoff or flood events. Additional spawning habitat would likely result. This would however, need to be documented.

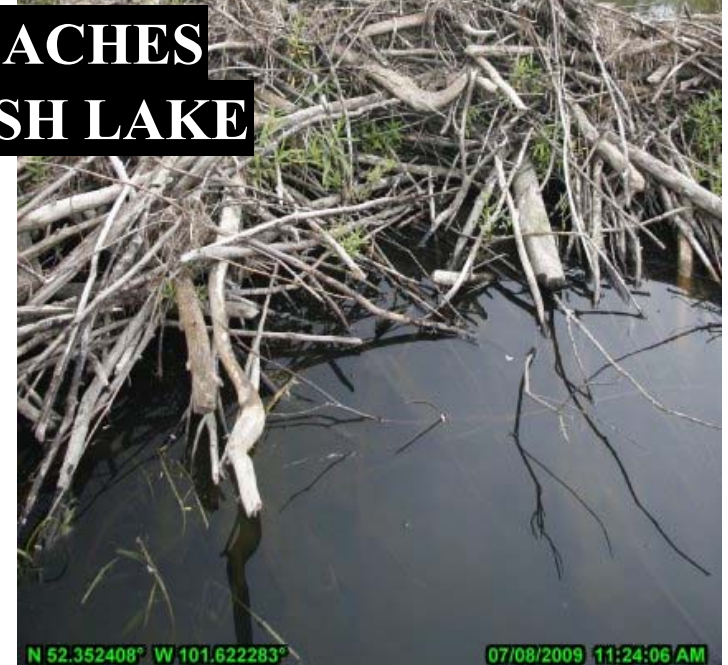
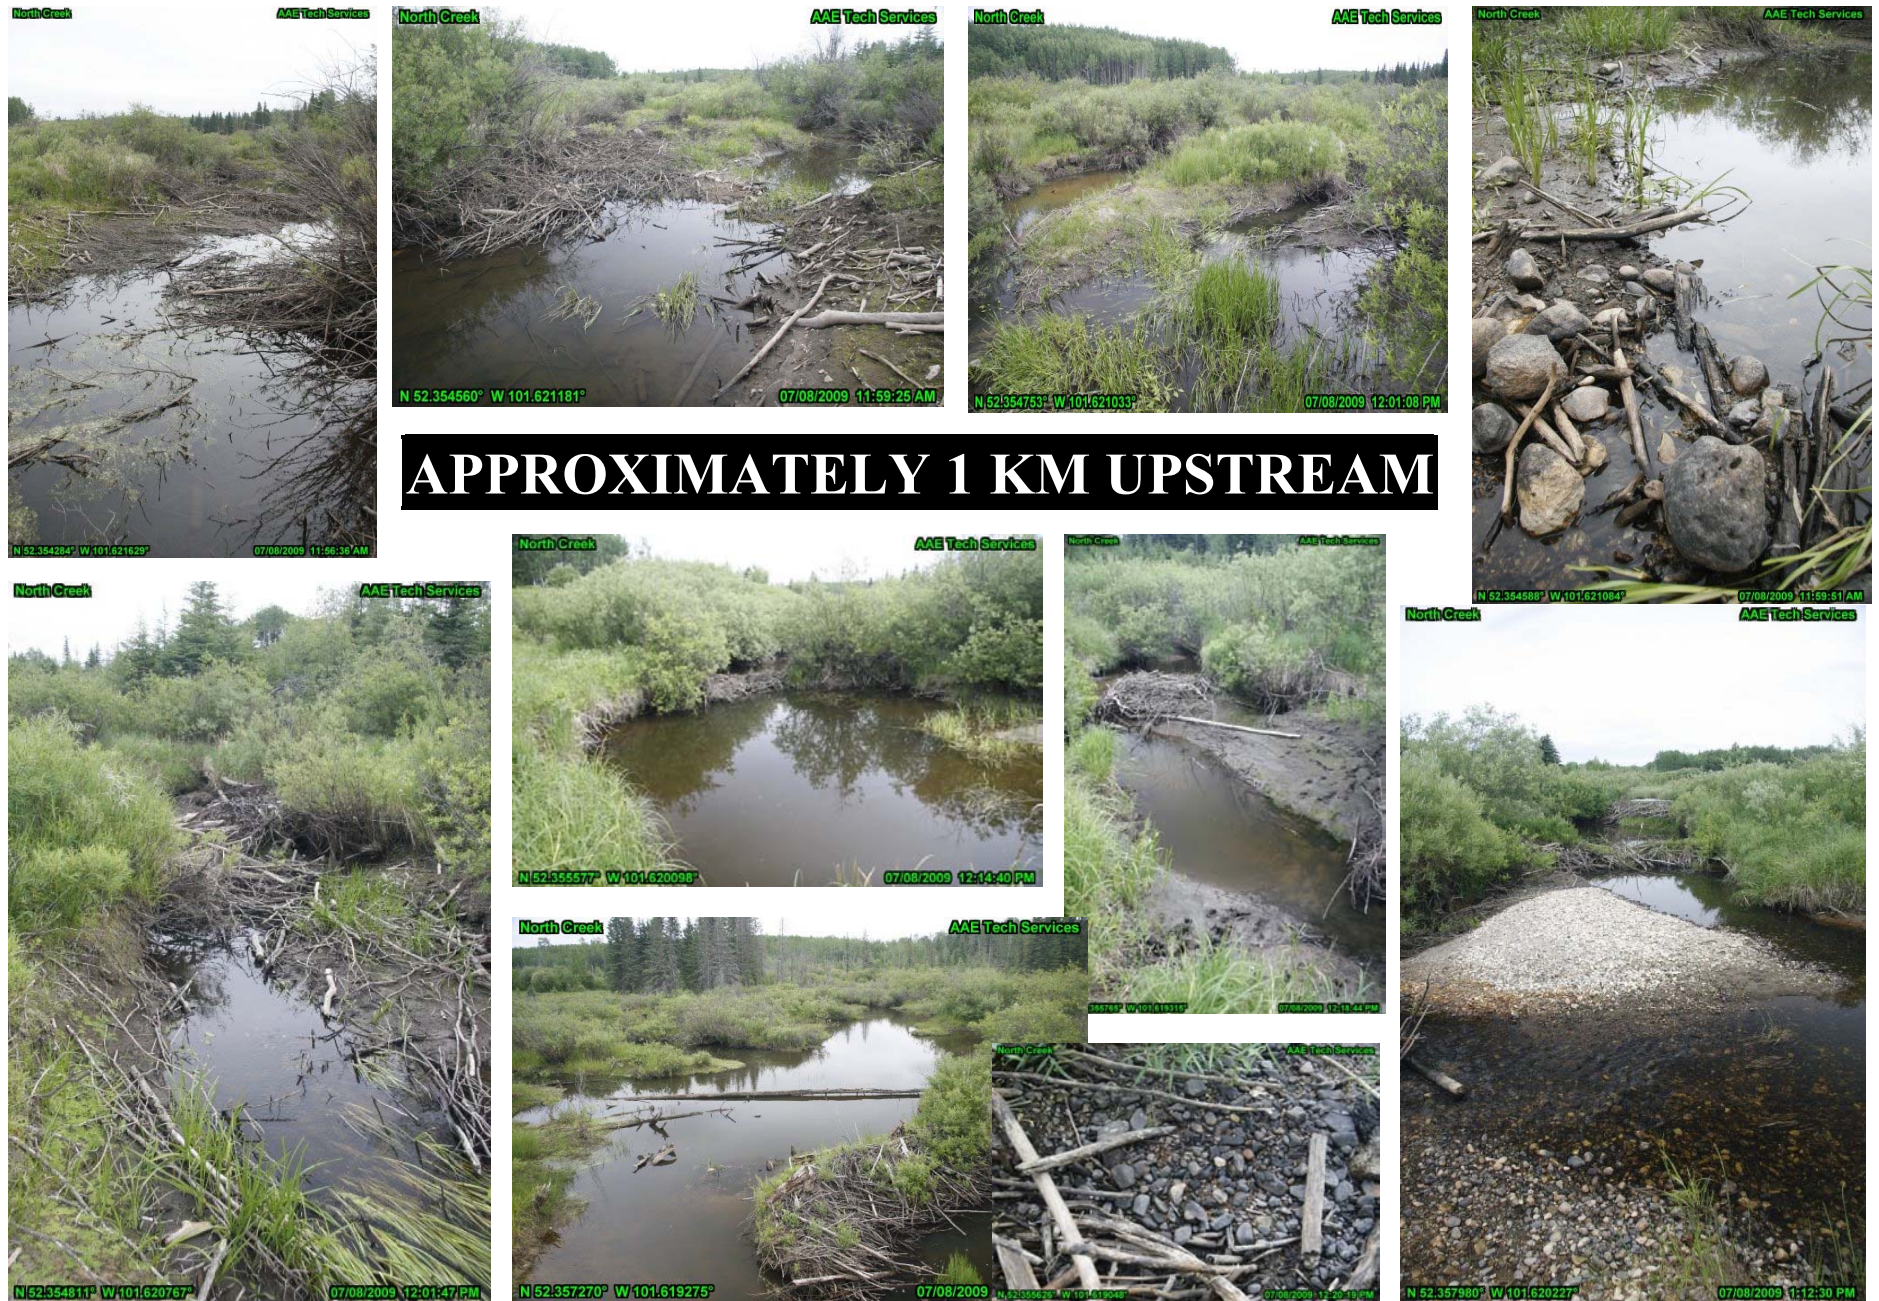
## LOWER SAMPLING REACHES WITH 1KM OF WHITEFISH LAKE

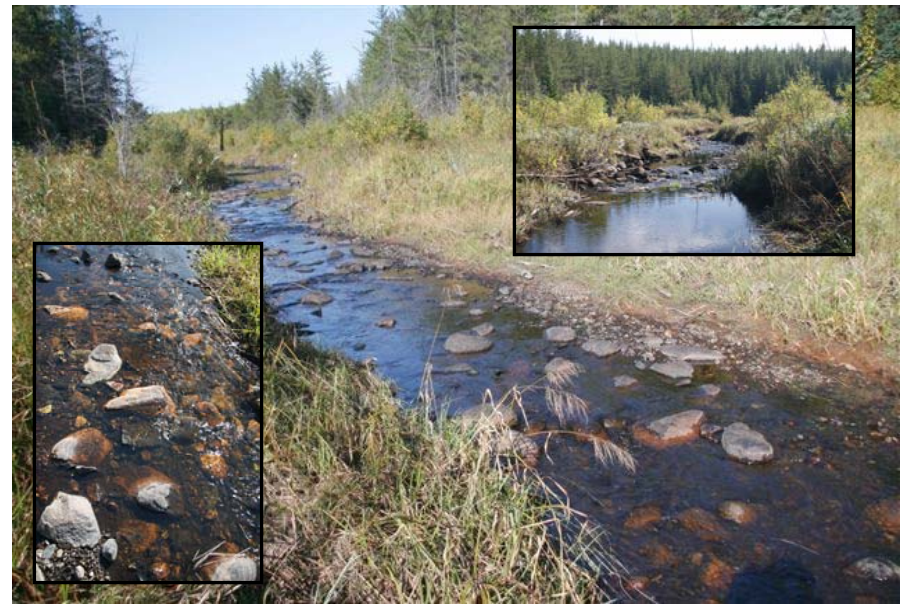
**APPROXIMATELY 4 KM UPSTREAM  
EXCELLENT WALLEYE SPAWNING HABITAT**

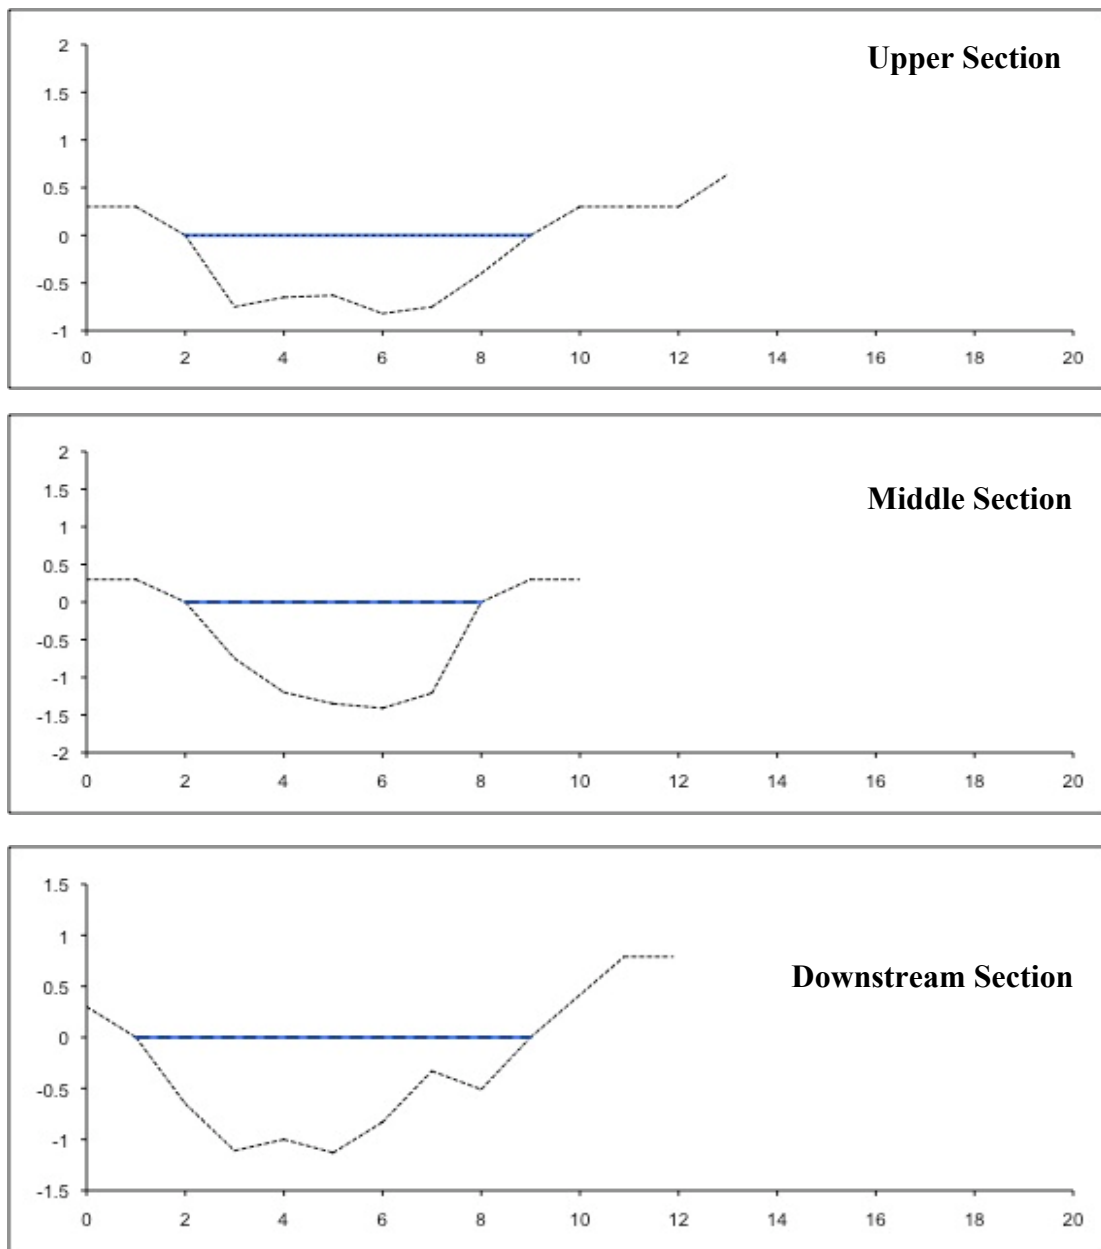
Cross-sectional profiles for reach #1, #2 and, #3 of Lagoon Creek and North Creek are shown below in Figure 7 and 8 respectively. Cross sections were conducted from July 10<sup>th</sup> to 17<sup>th</sup>.

**Figure 7.** Cross-sectional profiles for Lagoon Creek, 2009. Upstream (N52.33975 W101.56758), Middle (N52.34048 W101.57560), and Downstream (N52.33695 W101.58644).

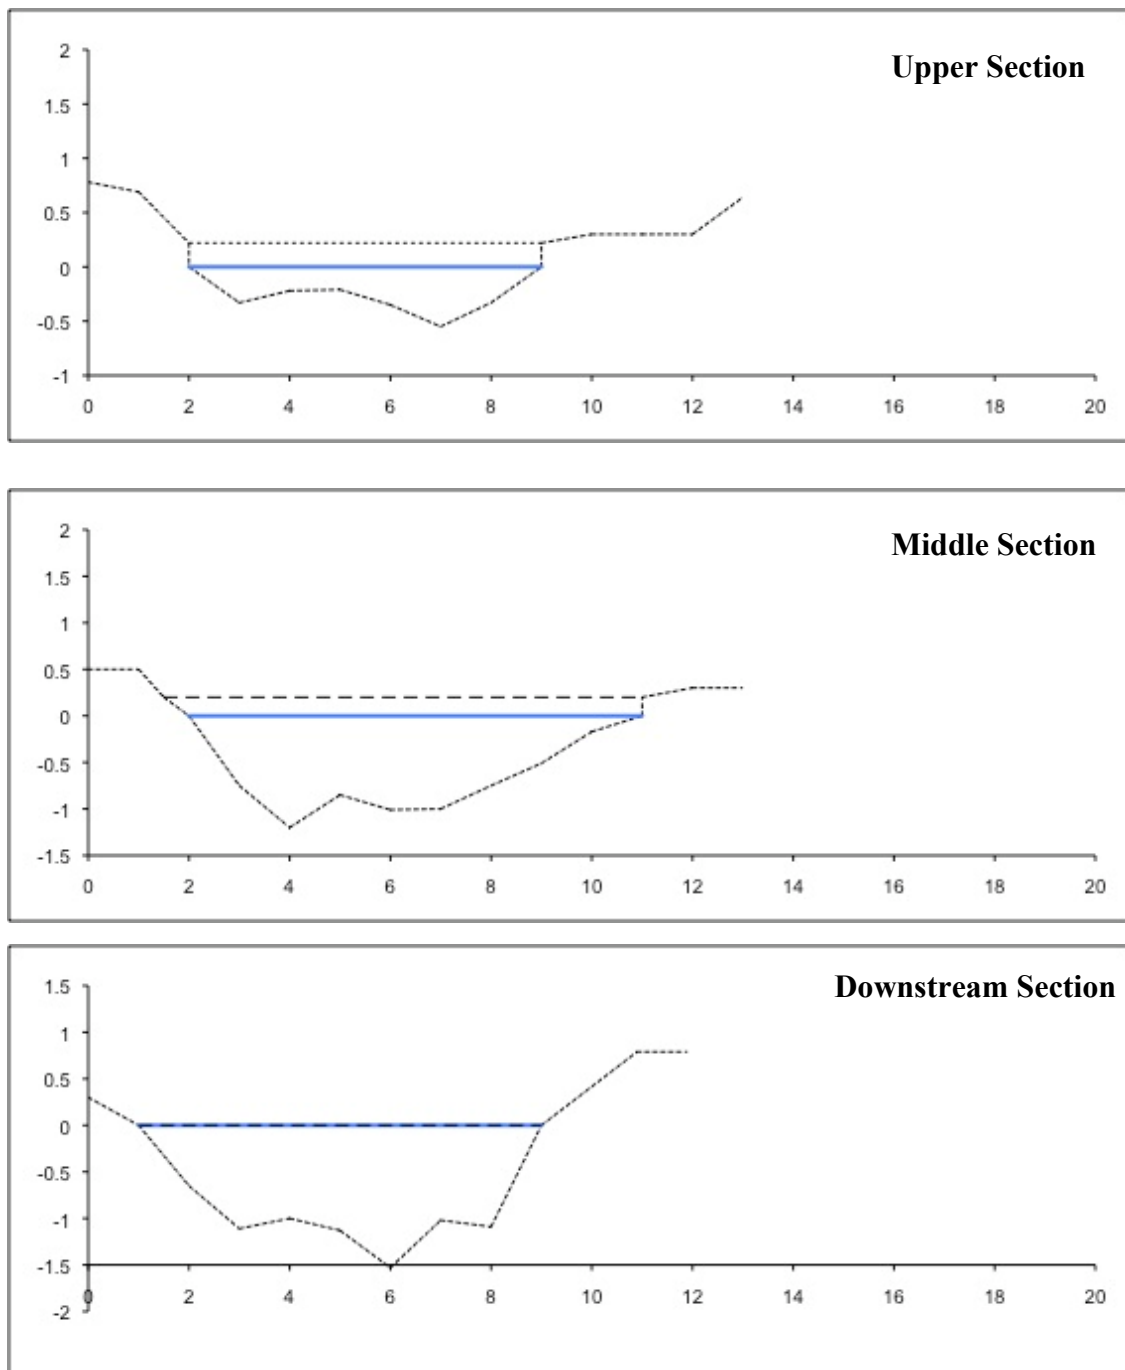
**Figure 8.** Cross-sectional profiles for North Creek, 2009. Upstream (N52.35804 W101.62051), Middle (N52.35516 W101.62045), and Downstream (N52.35241 W101.62229).

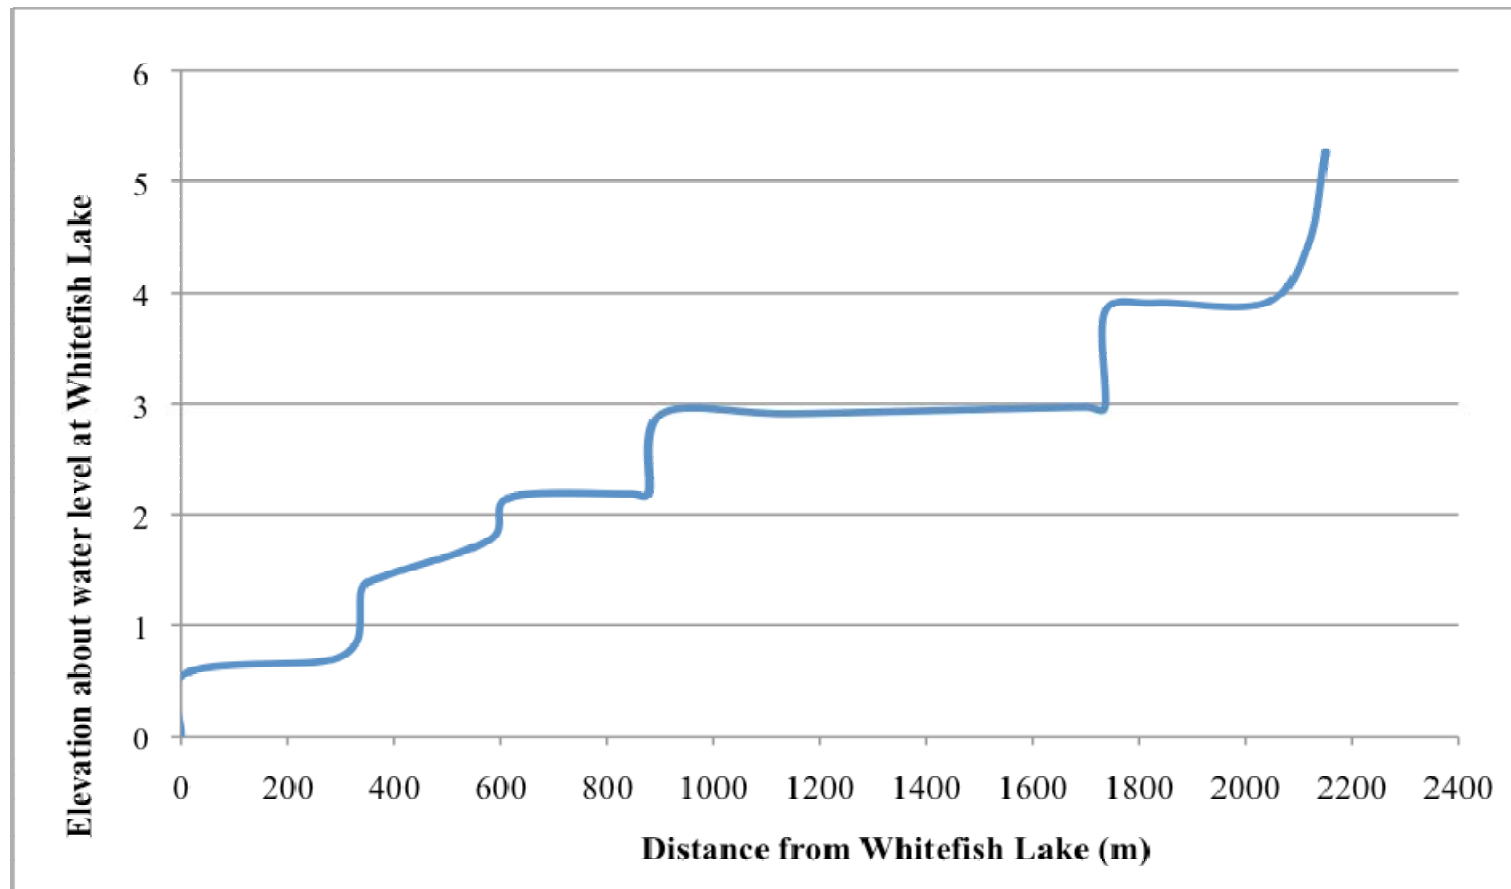
**Figure 10.** Lagoon Creek longitudinal profile based on water elevations at beaver dams locations within the creek. Notice the steep inclines at beaver dam locations.

- Remove all barriers on both creeks to provide additional spawning habitat for the Whitefish Lake fish community. Refer to the next section for recommended beaver management practices.

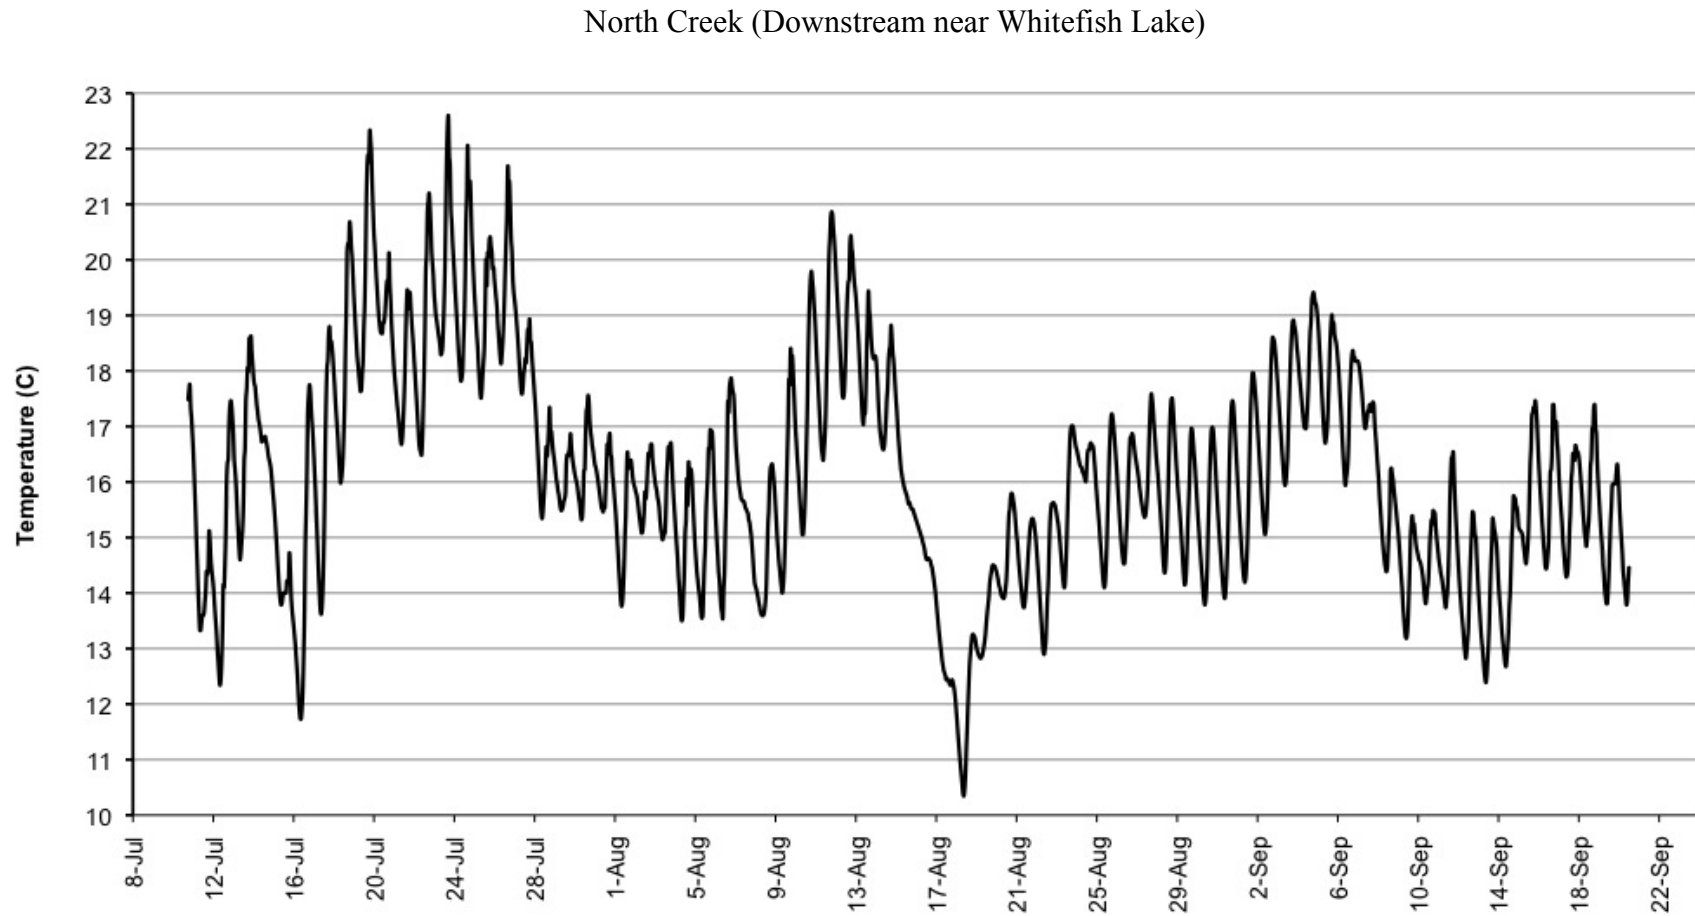
The results during the project indicated temperature ranges were well within the tolerance levels of most fish species within both Lagoon and North creeks. Temperature range for Lagoon Creek was 11.4 to 17.5°C (Figures 11 and 12). The temperature range for North Creek of 10.3 to 22.6°C was slightly higher than found within Lagoon Creek (Figures 13 and 14). Water reached higher temperatures during the day and lower temperatures at night as a result of the smaller volume of water within the shallow pools located on North Creek.

**Figure 13.** Water temperature (°C) data for the North Creek near Whitefish Lake (N52.35241 W101.62229).

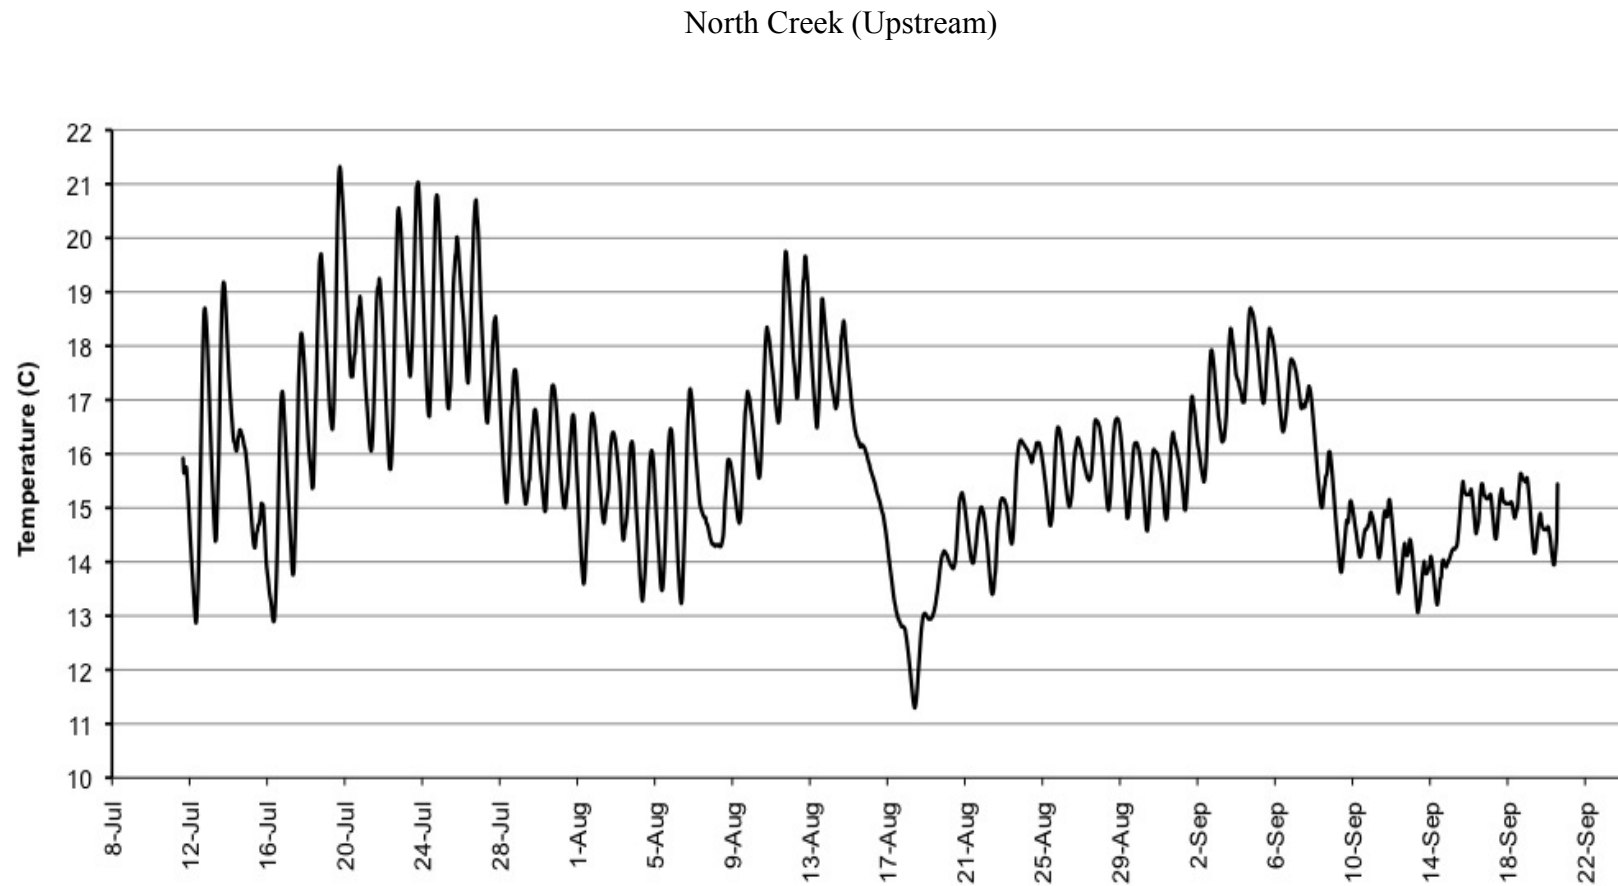
**Figure 14.** Water temperature (°C) data for the North Creek upstream (N52.35804 W101.62051).

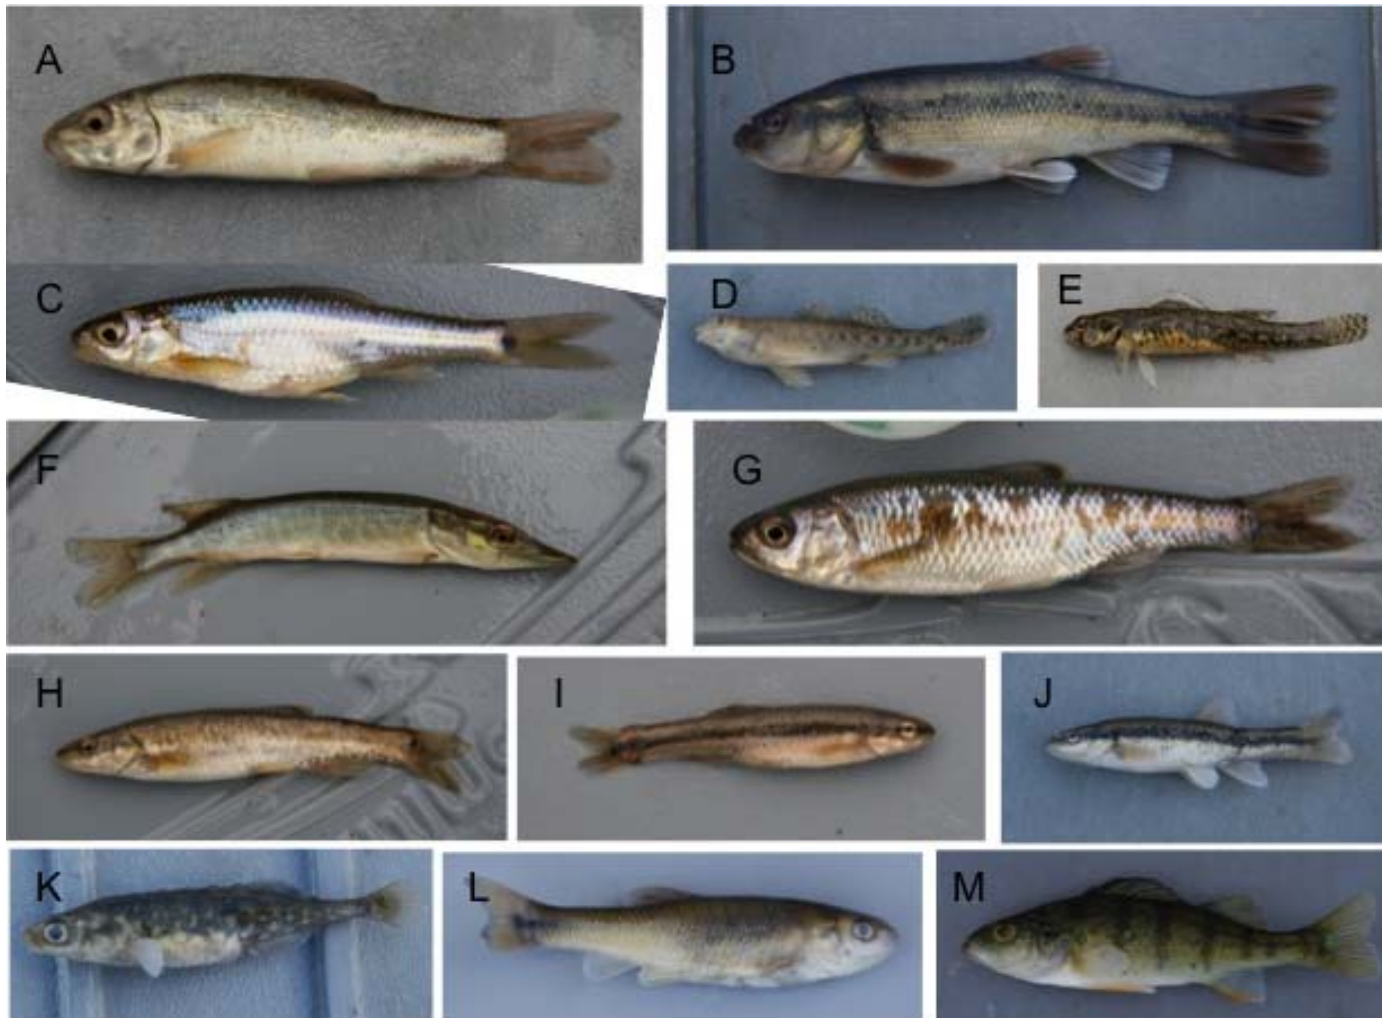
**Figure 15.** Photos of representative fish species capture during the fish inventory on the Whitefish Lake Tributaries, 2009. A – White sucker, B – Creek Chub, C – Spottail Shiner, D – Johnny Darter, E – Iowa Darter, F – Northern Pike, G – Common Shiner, H – Longnose Dace, I and J – Western Blacknose Dace, K – Brook Stickleback, L – Fathead Minnow, M – Yellow perch.

A total of 659 fish, representing 15 species were captured within the two Whitefish Lake tributaries (Appendix C). Photographs of representative specimens are displayed in Figure 15. Common Shiners (*Luxilus cornutus*) and Fathead Minnow (*Pimephales promela*) were the dominant fish species found within Lagoon Creek representing 61 and 31% of the catch respectively. Brook Stickleback (*Culaea inconstans*), Johnny Darter (*Etheostoma nigrum*), Finescale Dace (*Phoxinus neogaeus*), and Western Blacknose Dace (*Rhinichthys obtusus*) were also found within Lagoon Creek. All of these fish likely over-winter within the creek. White Sucker (*Catostomus commersonii*), Yellow Perch (*Perca flavescens*), Northern Pike (*Esox lucius*), and Walleye (*Sander vitreus*) were not captured within the creek. Commonly found within Whitefish Lake, suggest the barriers situated within Lagoon Creek most likely impede all fish movement.

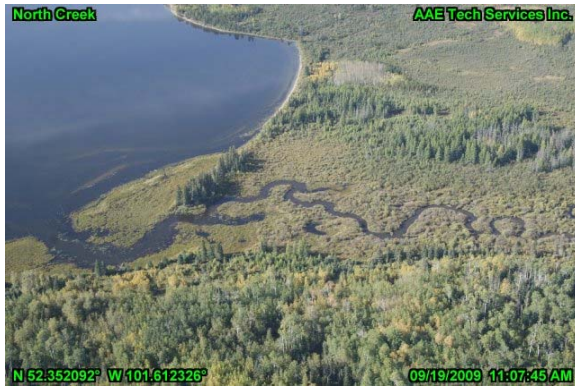
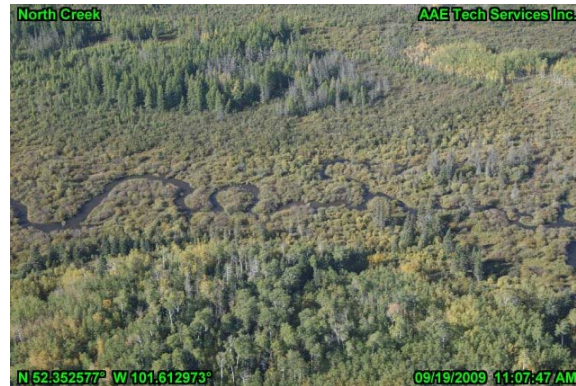
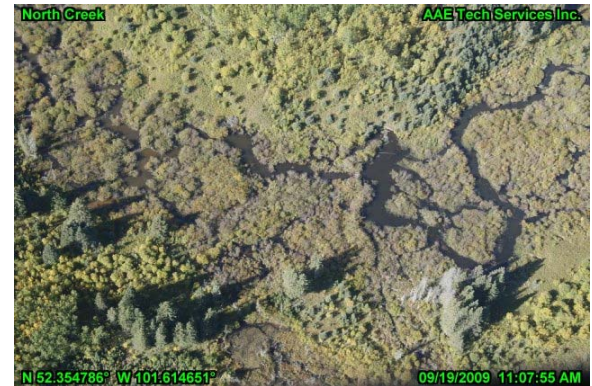
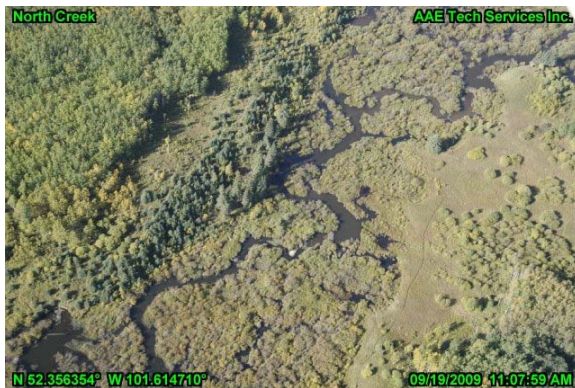
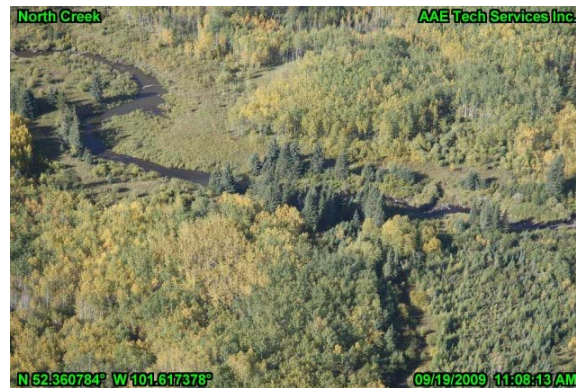
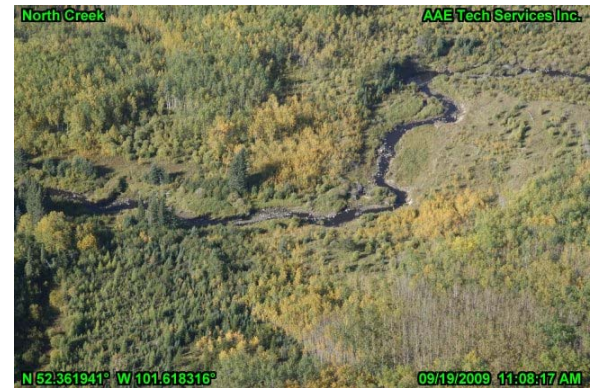
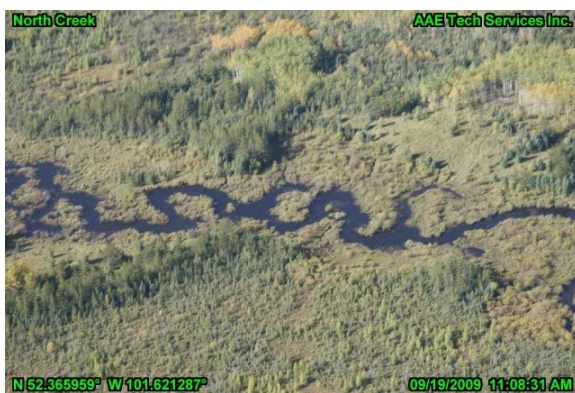
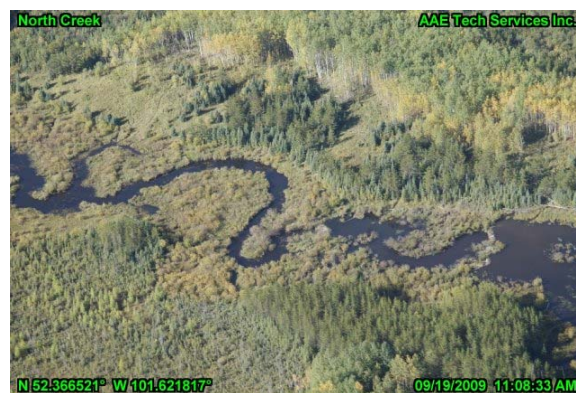
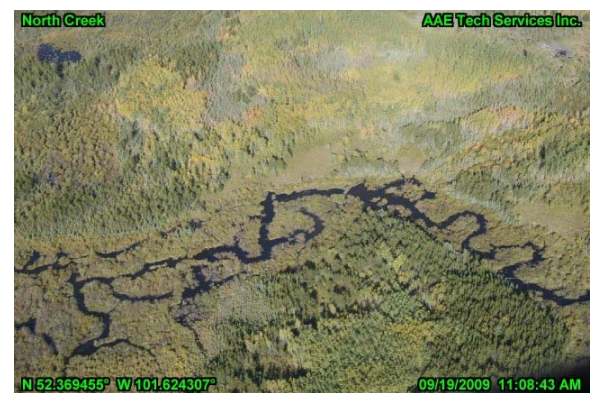
**APPENDIX B: AERIAL PHOTOS NORTH CREEK**

(photographs are moving upstream from Whitefish Lake, flow is therefore in the opposite direction – bottom left corner to top right)

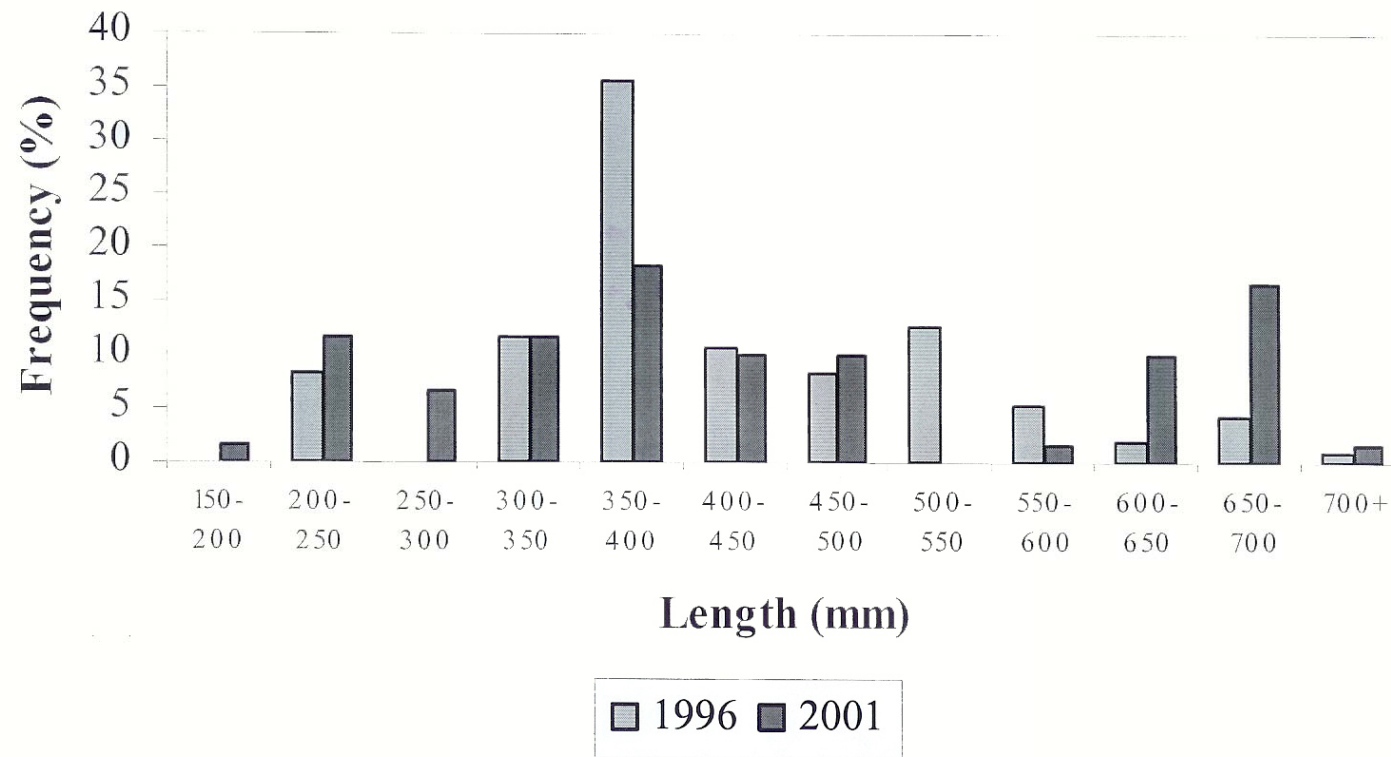
**Figure 8. Walleye Length Frequencies - Whitefish Lake,  
1996 (n=95) vs. 2001 (n=60)**

1996 mean length=414.4 2001 mean length=431.7
