# Summary of Activities

**Date:** November 13<sup>th</sup>, 2018

**From:** Holly Urban, Brock Koutecky,  
Megan Paterson - Swan Valley Sport  
Fishing Enhancement Technical Staff

**Subject:** 2018 Dissolved Oxygen Testing and Winterkill Investigations

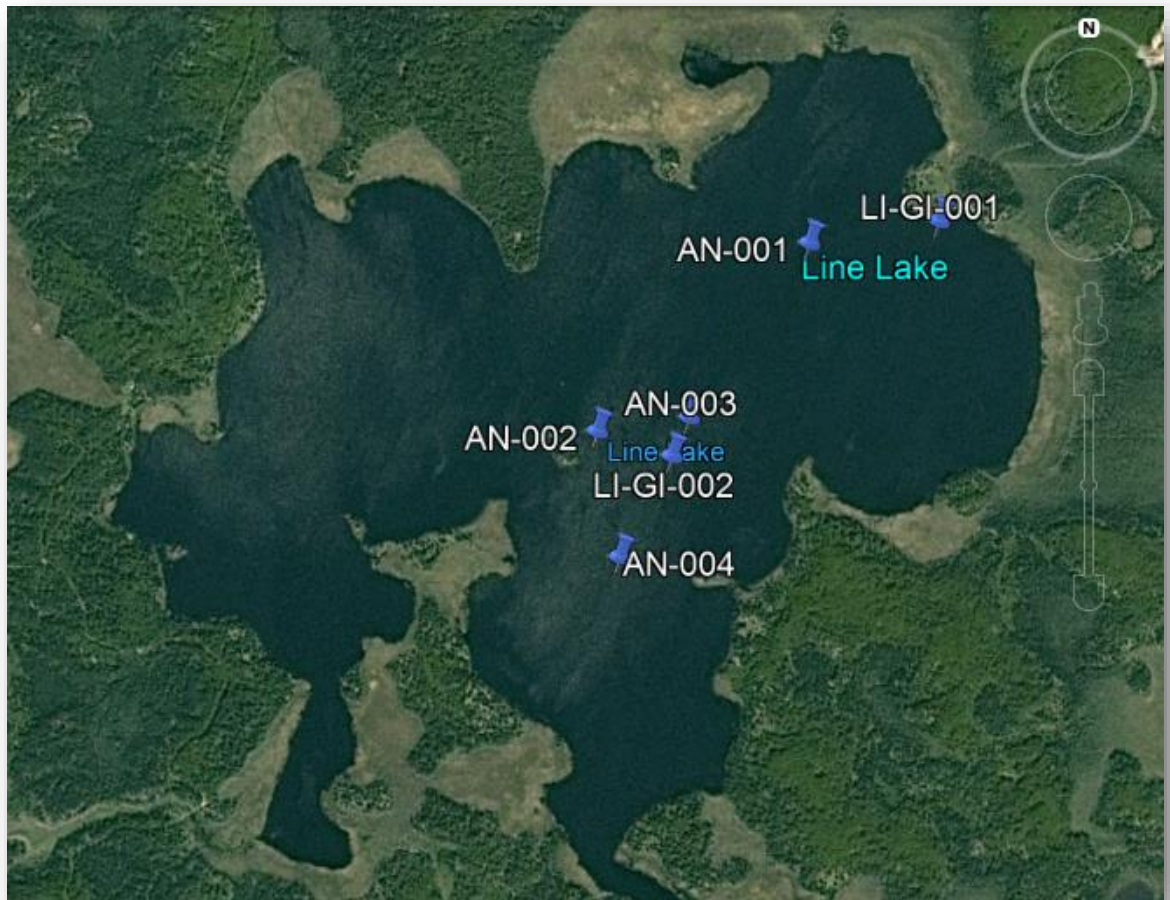
On July 10<sup>th</sup>, 2018 two standard gang gill nets (LI-GI-001 & 002) were set for 2 and 1.6 hours respectively (figure). In addition, technicians angled various locations while mapping and while nets were fishing in efforts to assess the pike survival.

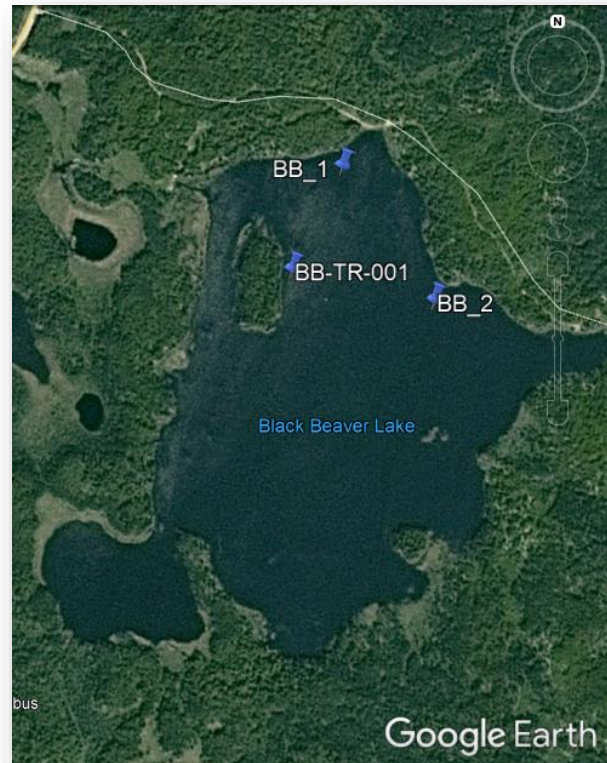
**Black Beaver Lake:** Dissolved oxygen profiles were collected at two locations on April 4<sup>th</sup>, 2018; BB\_1 - the north shore and BB\_2 - Palmer's Point. These sites typically yield fair to excellent DO levels compared to any other locations on the lake. Results are listed in the table below.

On July 4<sup>th</sup>, 2018, technicians set one overnight small mesh (1/4") trap net on the northeast side of the island (BB-TR-001). The trap fished for 20.5 hours. Results indicate low survival of the existing trout population. A total of 13 small brook trout were caught ranging from 150 - 187 mm. All brook trout caught were from the May 31<sup>st</sup> stocking.
