2020 Whitefish Lake Tributary Surveys

In part of reporting for FES Project 19-035
Recreational Fisheries Enhancement and Youth
Angling Opportunities in the North Parkland

Swan Valley Sport
Fishing Enhancement Inc.

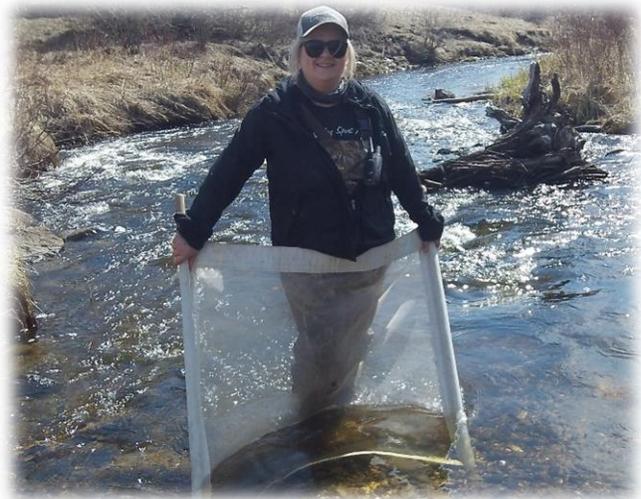
Figure 1: Kick net

While travelling to the site locations technicians document the reconstruction of beaver dams, egg presence/absence, fish presence/absence, while also ensuring as little disturbance to the substrate as possible during travel. The kick netting technique involves placing the net poles firmly on the creek bottom and disturbing the substrate by "kicking" the substrate upstream of the net. The kick net used is a 1 m² net with 0.5 mm (500 micron) mesh

screening attached to two poles (Figure 1). The current carries and distributes material onto the net. Each site was kick sampled for 60 seconds with one square meter of area sampled. Species, number of eggs and condition of eggs (alive, dead, eyed) were documented and placed back into the stream. With sites of high egg concentrations, counts were estimated in order to return eggs back into the water as quickly as possible. In addition, water temperature, weather, substrate type present and additional comments were recorded.

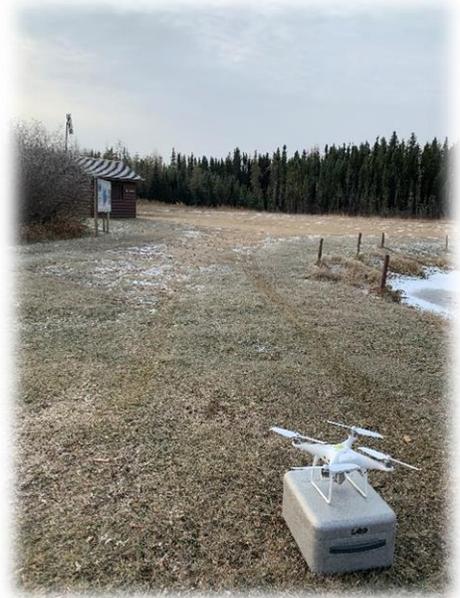
Figure 2: Drone used for inventory of Lagoon Creek barriers

Inventory of barriers is typically conducted in the fall by travelling upstream creeks by boat and then by foot when boat access is restricted. Technicians flag each barrier and document; coordinates, barrier width, height, dam material plus take reference photos. All information is provided in digital and paper format for future reference while dam blasting occurs. In 2020, a drone was used to identify barriers on Lagoon Creek as the creek had froze over and was unsafe for travel. The Swan Lake Watershed District donated the use and technician time to record video of the barriers. From the video, SVSFE technicians geo-referenced the dams and flagged them once ice conditions were safe.

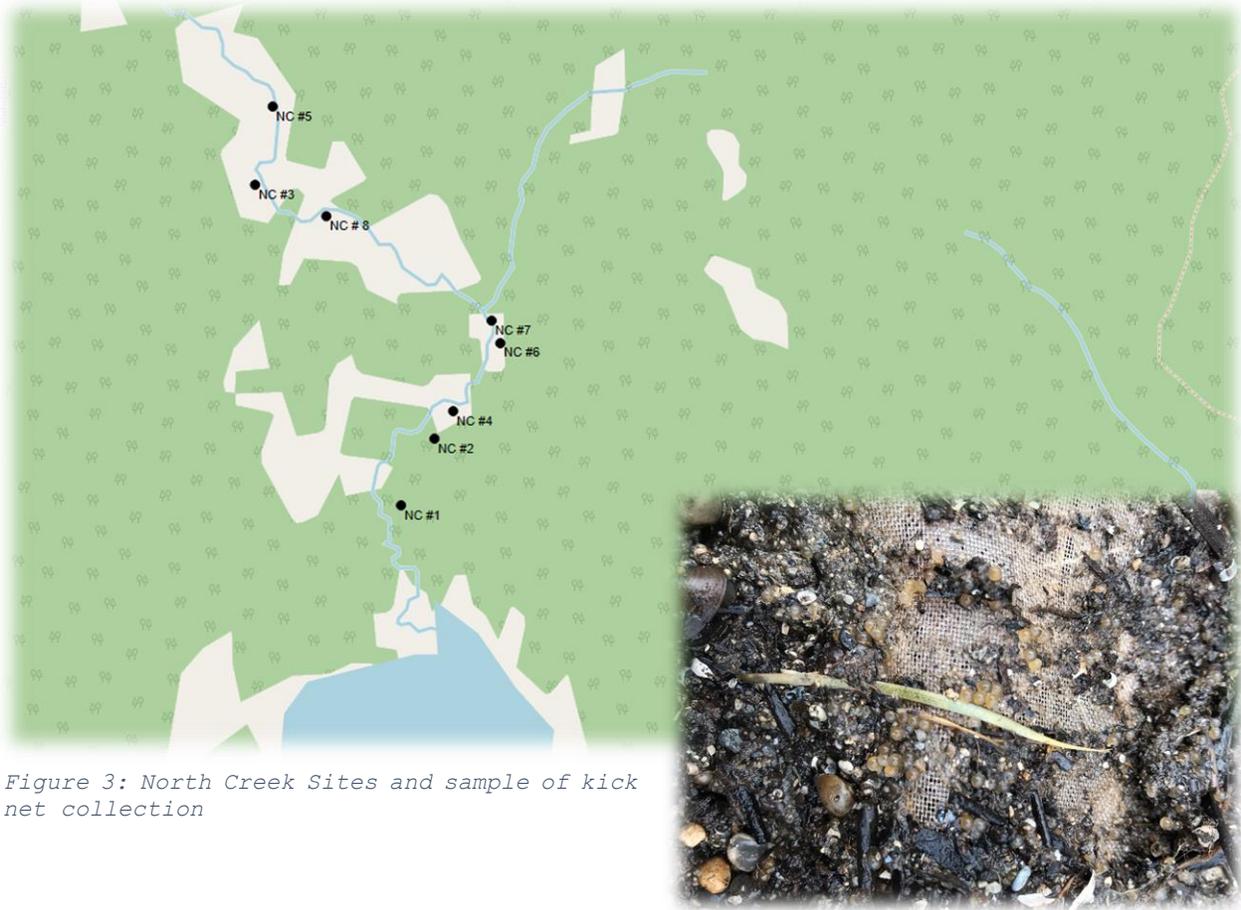
Figure 3: North Creek Sites and sample of kick net collection

North Creek was assessed for spawning activity and success on May 28th, which ended up being post-spawn in 2020. Technicians travelled up North Creek to conduct kick-sampling at eight predetermined sites.

Location	Date	Species	Count	Comments
North C. 001	May 28/2020	WALL	100	All eggs dead
North C. 002	May 28/2020	WALL	200+	All eggs dead - Walleye remains in area
North C. 003	May 28/2020		0	
North C. 004	May 28/2020	WALL	1	Dead
North C. 005	May 28/2020	WHSC	17	Dead
North C. 006	May 28/2020		0	
North C. 007	May 28/2020		0	Dead
North C. 008 (New 2020)	May 28/2020	WHSC	15	Dead

2020 kick-sampling surveys were conducted post hatch and therefore utilization was quantified by sampling for dead eggs. Interestingly, walleye eggs are found annually at site 4 but never beyond it in North Creek. Although migration and suitable habitat continues beyond site 4 walleye tend not to travel beyond it (~1.3km of stream distance from lake). Comparison egg CPUE's to past years the results were similar with both Site 1 and 2 being the most productive. In 2020, sucker eggs were found as far as site 5 (~3.6km of stream distance from lake).

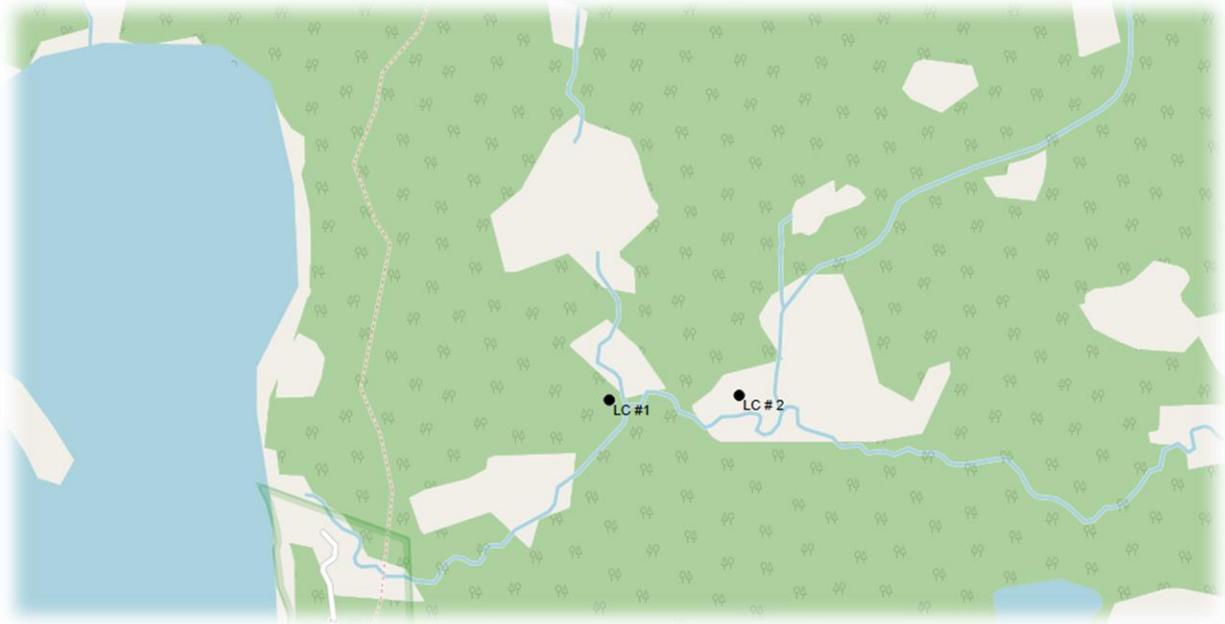
Figure 4: Lagoon Creek Sites

Lagoon Creek was also assessed on May 28th, 2020. This was the first time in recent history where evidence of walleye utilization was found in Lagoon Creek.

Location	Date	Species	Count	Comments
Lagoon C. 001	May 28/2020	WALL	200+	All eggs dead
Lagoon C. 002	May 28/2020	-	-	Too deep could not sample

For the first time since 2017 walleye eggs were found in Lagoon Creek. This is a very encouraging result and justifies the continuation of barrier removal and creek rehabilitation in Lagoon Creek in future years. Whitefish Lake is arguably one of the most popular walleye destination in the Porcupine Mountains. In addition, it is also one of the only walleye fisheries in the Swan Valley not requiring supplemental stocking. Positive impacts from population monitoring and management are apparent in the success of the fishery. To preserve this success, SVSFE strongly supports the continuation of beaver dam management and spawn assessment monitoring on Whitefish Lake.

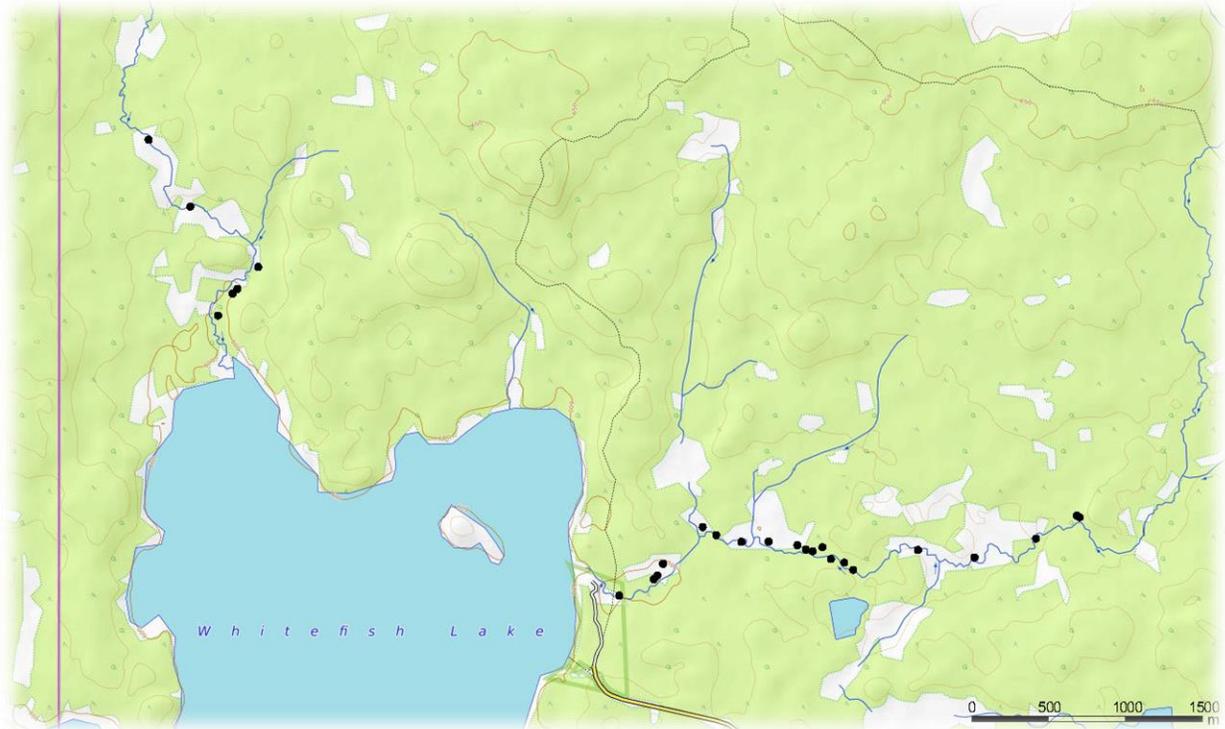
Figure 6: Overview of barriers on North and Lagoon Creek

On October 15th, 2020 barriers on North Creek were identified. A total of six priority dams were identified for removal. Dams ranged from 0.3 to 2 m in height and were considered unstable (constructed with small sticks) to moderate (constructed with logs, sticks, mud). Barriers on Lagoon Creek were inventoried on Oct 20th with the drone. A total of 20 dams were identified as priority and reaches which have never been explored were viewed thanks to the use of the technology. Barriers were later flagged in January of 2021.
