# 2022 Honoway Fishway Monitoring

In part of reporting for FWEF Project 22-010 SVSFE  
Initiatives and Monitoring of Recreational Fisheries in  
the Swan Valley Area

Author: Brock Koutecky

October 2022

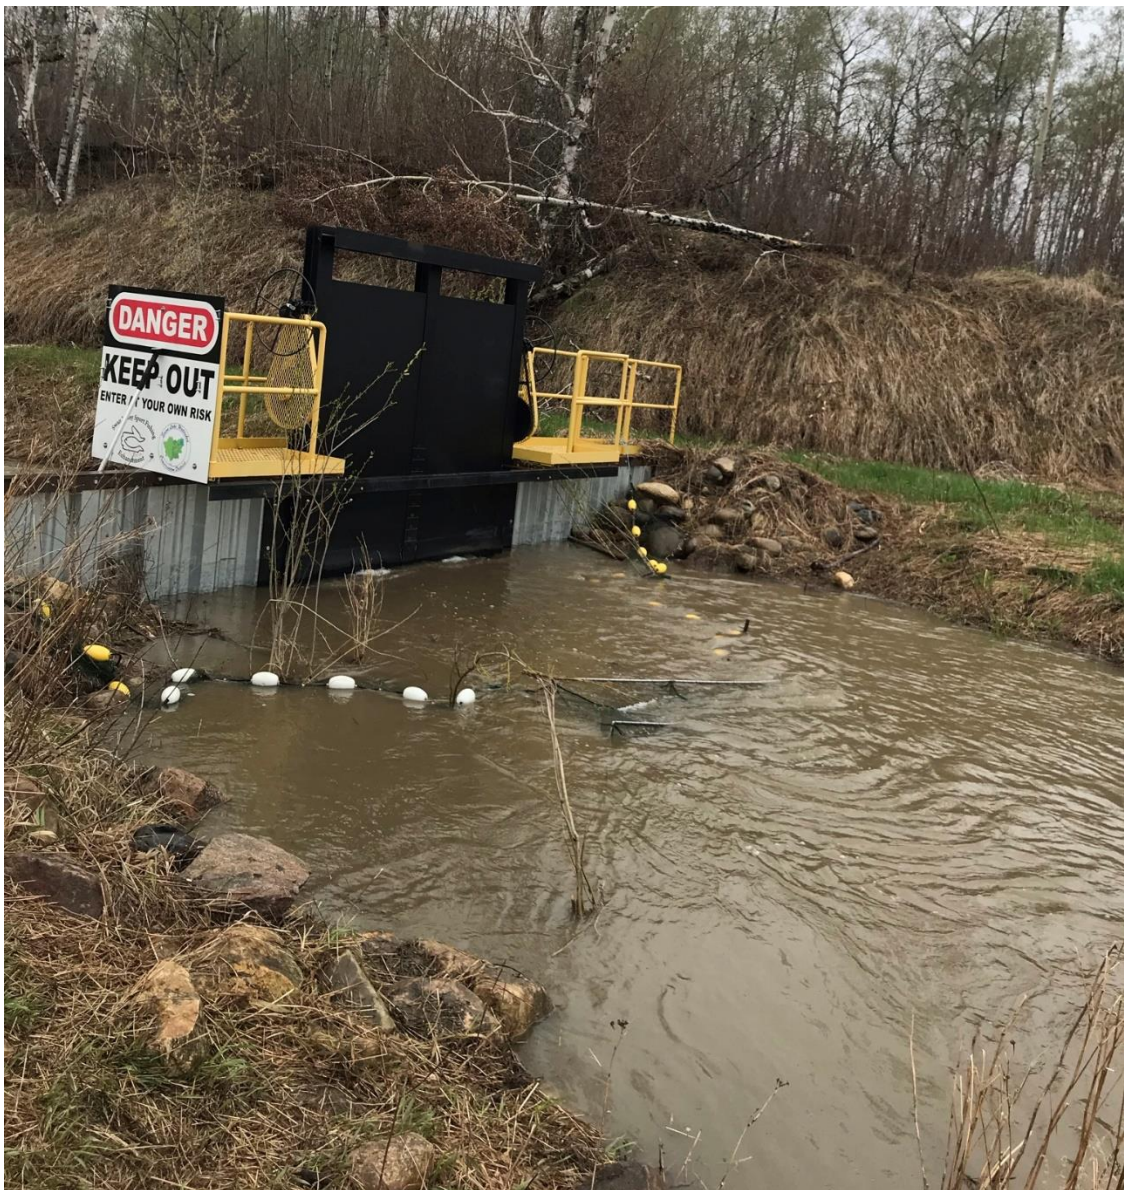
Figure 5: Honoway Fishway Netting Location - May 19<sup>th</sup>, 2022

Fish usage was quantified through trap-netting upstream of the control structure. A ridged framed trap net was fastened with a t-post upstream of the structure and wings were used to fish the entire stream width. Nets fished for either one hour or 30 minutes. As an issue of safety, netting was not completed when water levels were >1.4m. Non-game fish were counted, while game fish were measured and sexed to determine ripeness. All fish were released in slack water upstream of the netting location (Figure 6).

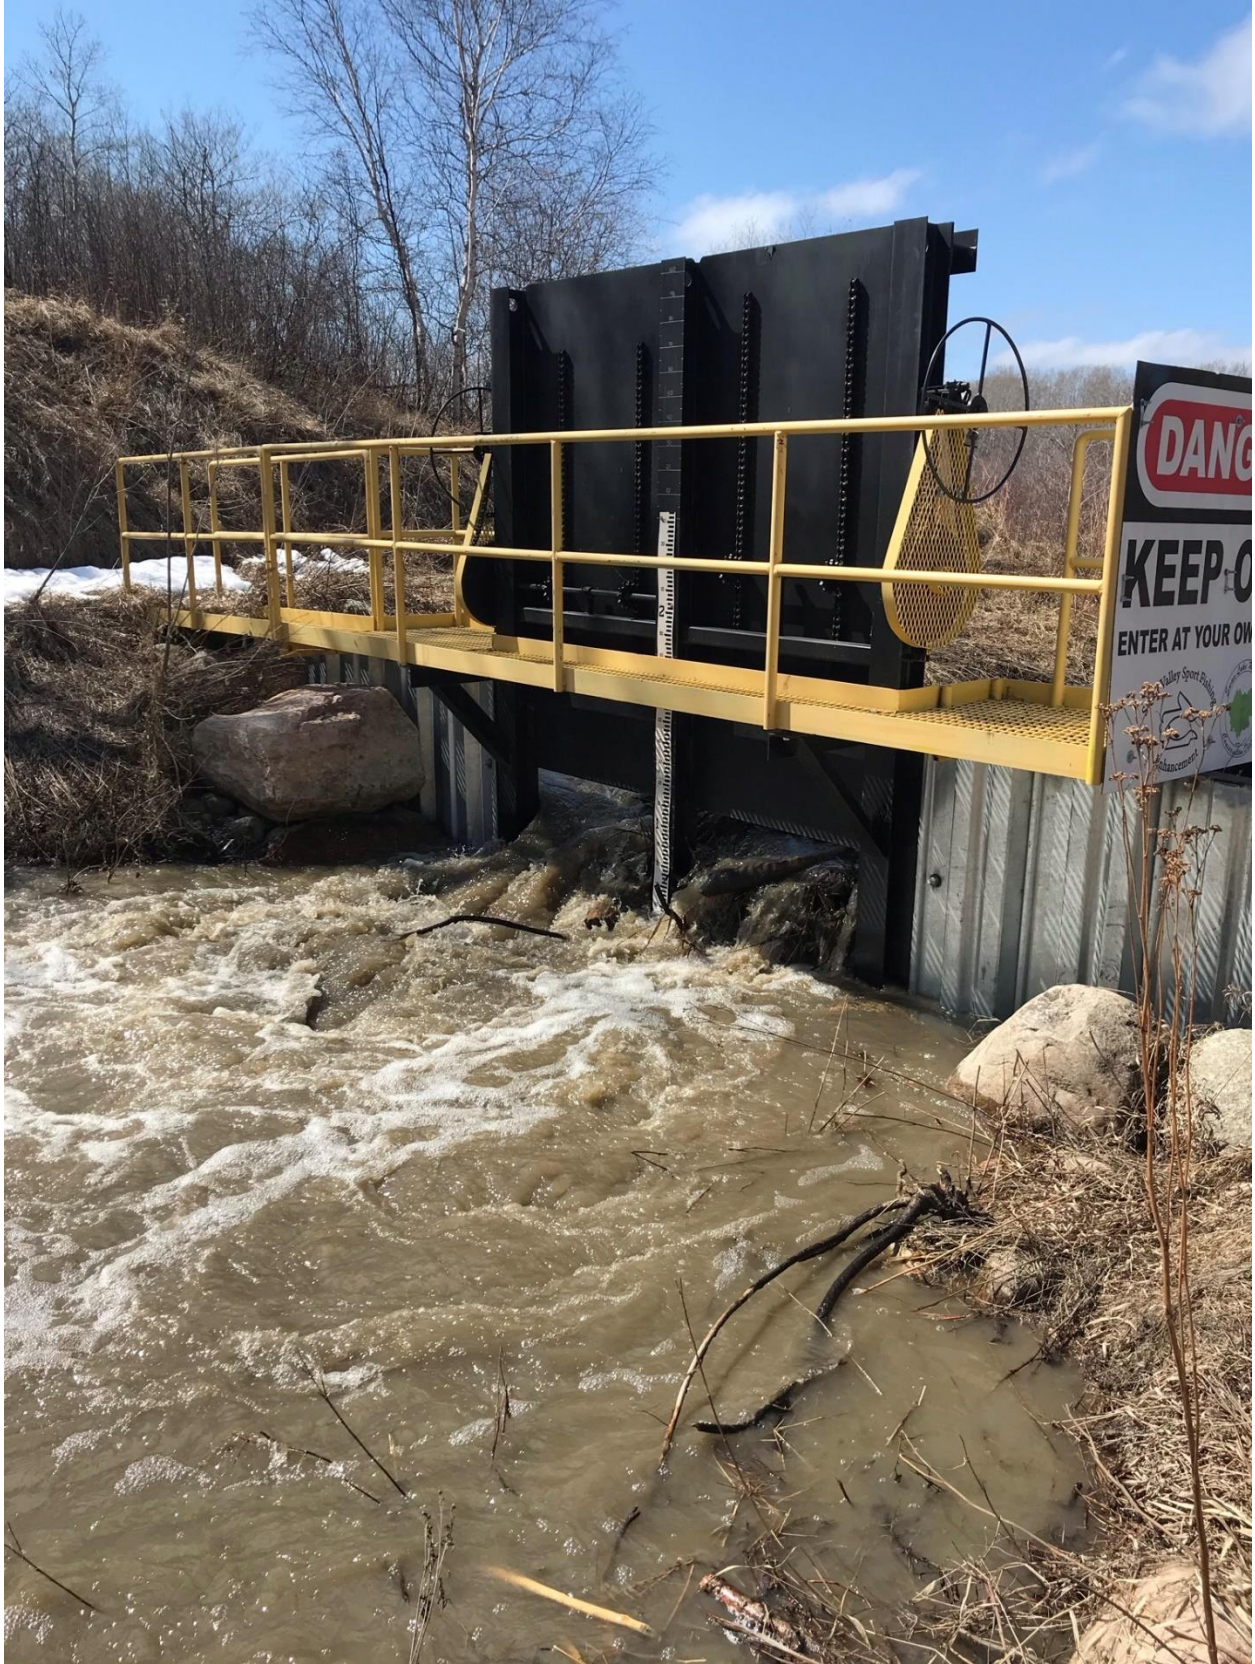
*Appendix 2: Control Structure With Debris (May 1, 2022)*

Debris is an uncontrolled factor influencing the success of the fishway on any given year. For this reason, it is recommended that the water control structure be always left fully open (100cm) to alleviate debris build-up. Of course, this will not avoid debris build-up, but it will help. A large buildup can cause issues with lowering and lifting the gates, as well as damming at the water control structure. For this reason, fishway operators should visit the fishway every so often and clean out debris using safe methods. Safety should be number one priority when removing debris.

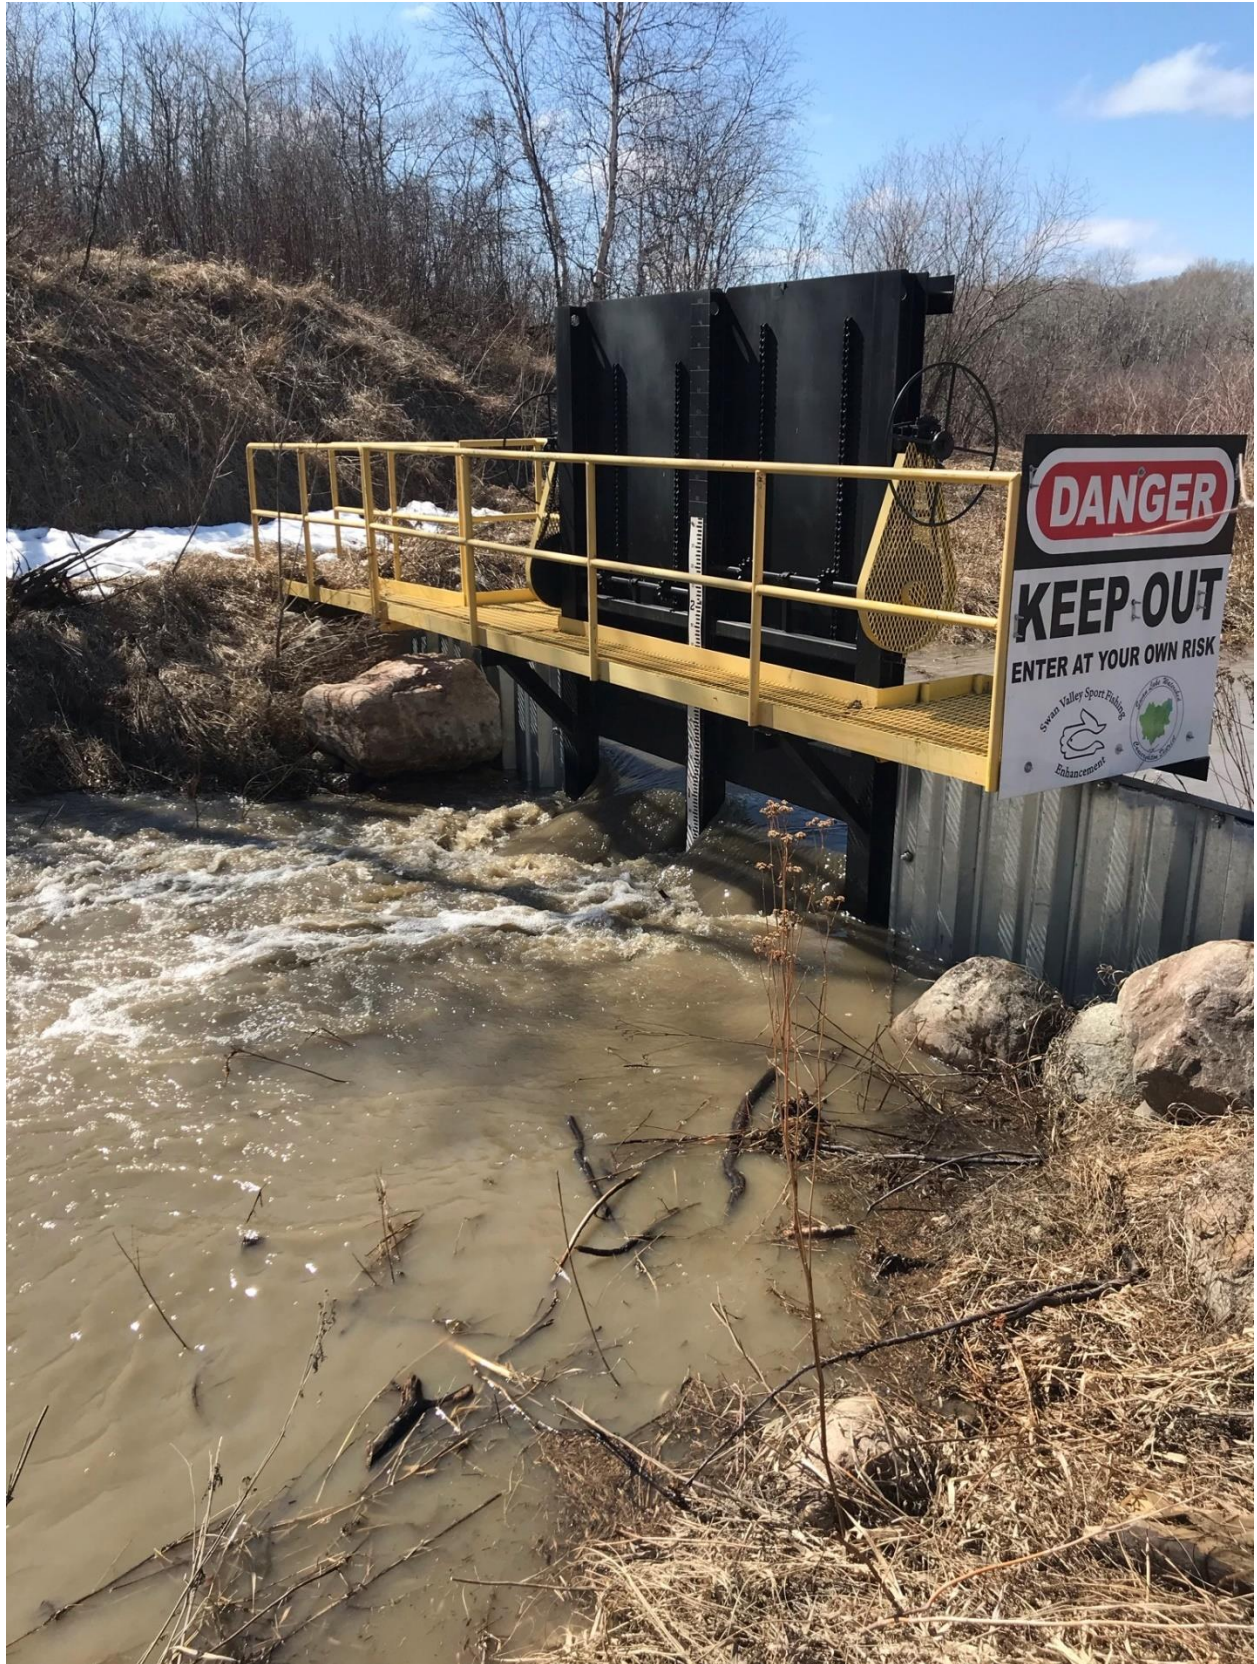
*Appendix 3: Control Structure Without Debris (May 1, 2022)*

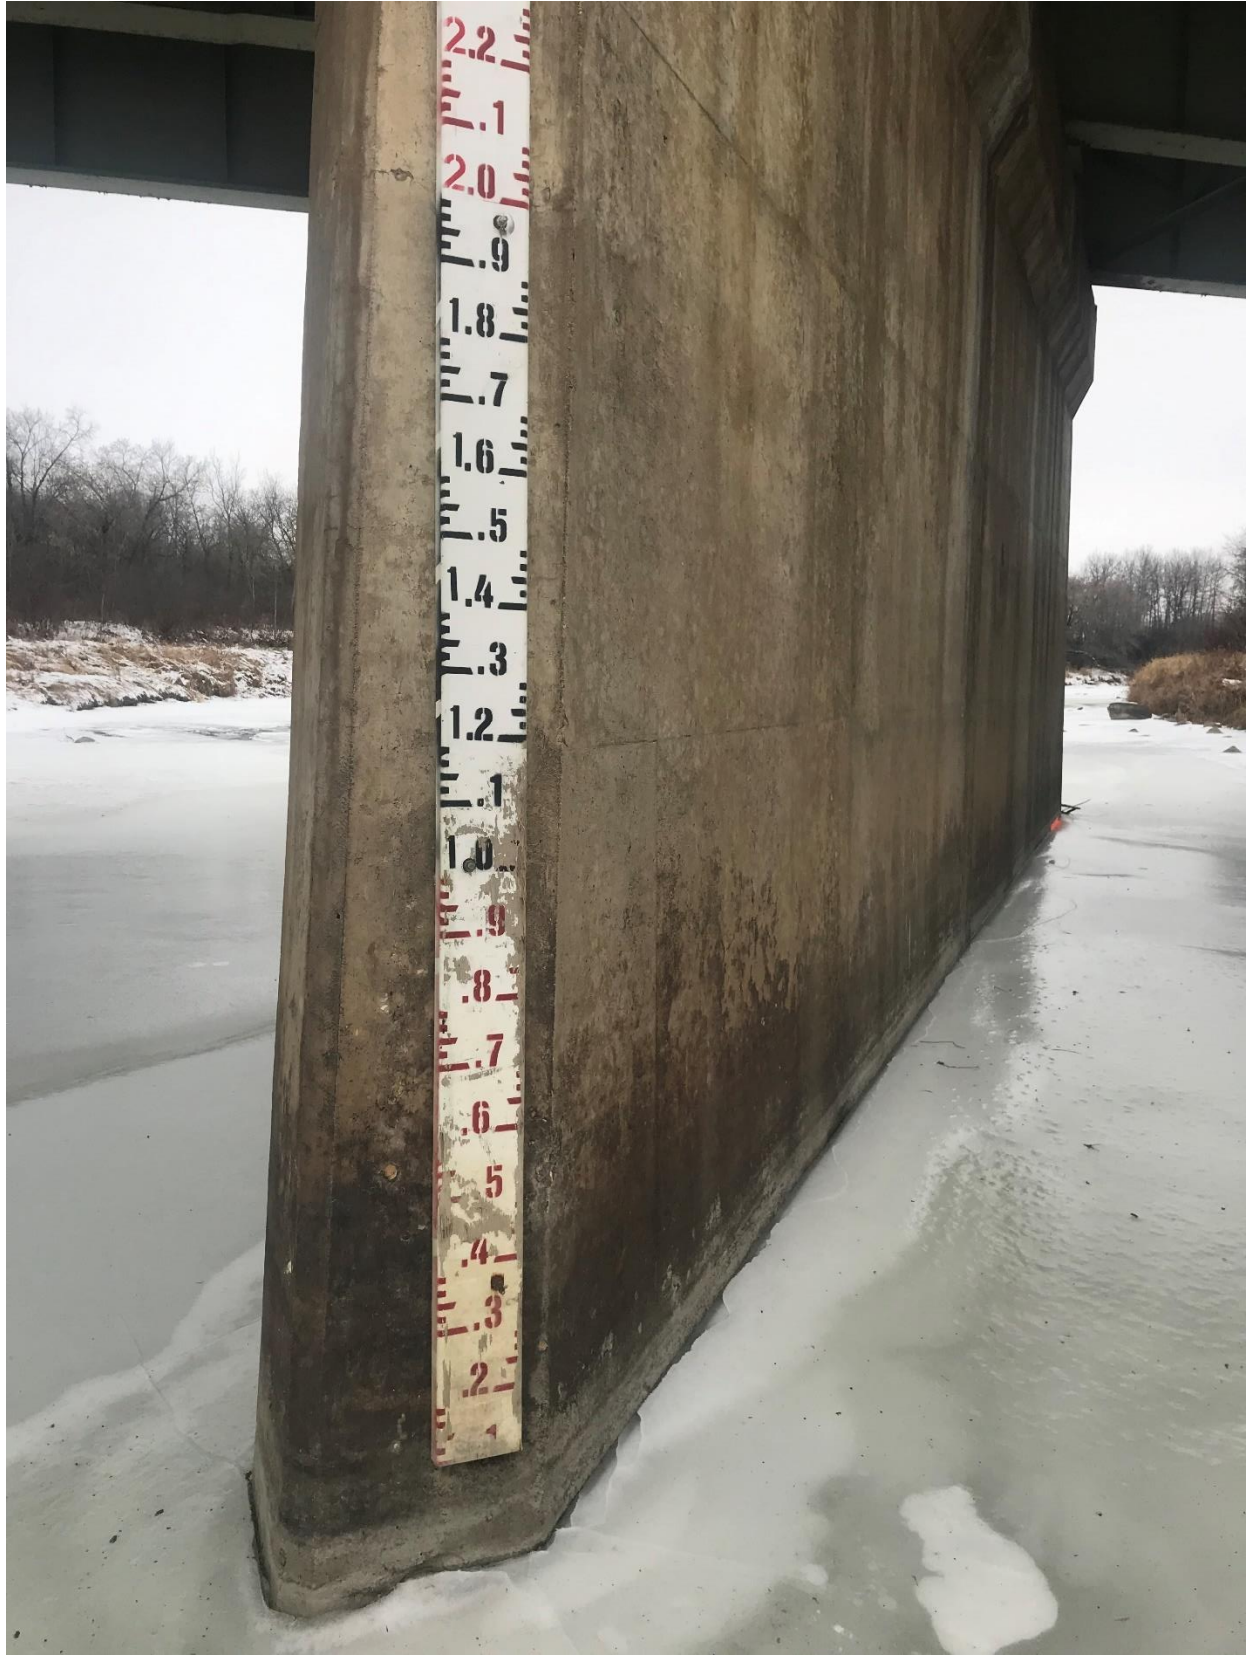
Appendix 4: Swan River Benchmark Water Level (HWY 10 Bridge)

The Swan River water levels can be measured at any time on the HWY 10 bridge (near the Swan Valley Historical Museum). The fishway is operable between water levels of 0.3m and 1.4m. Levels below 0.3m the fishway is dry and levels above 1.4m the water control structure will need to be used to decrease volume of water entering the fishway. Decreasing the water volume entering the fishway will decrease water velocities through the two mid-channel 22.5m culverts within the fishway.

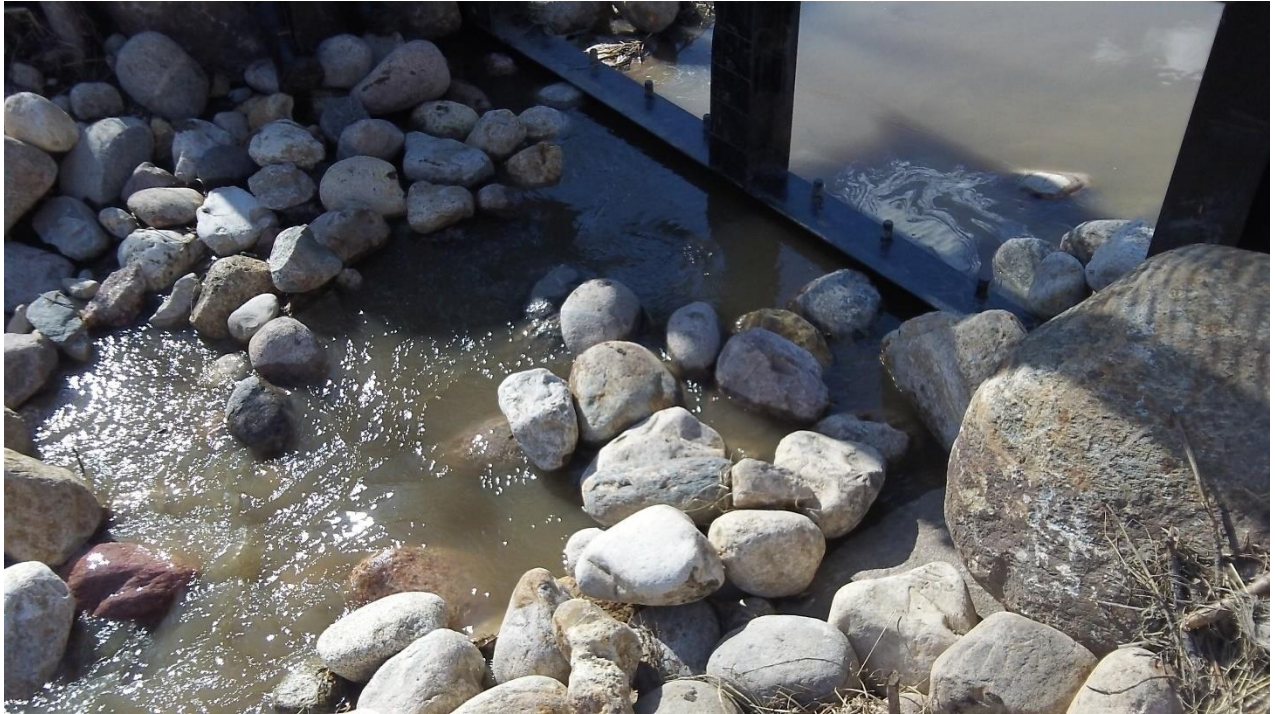
Appendix 5: Example of Low Water (0.3m)

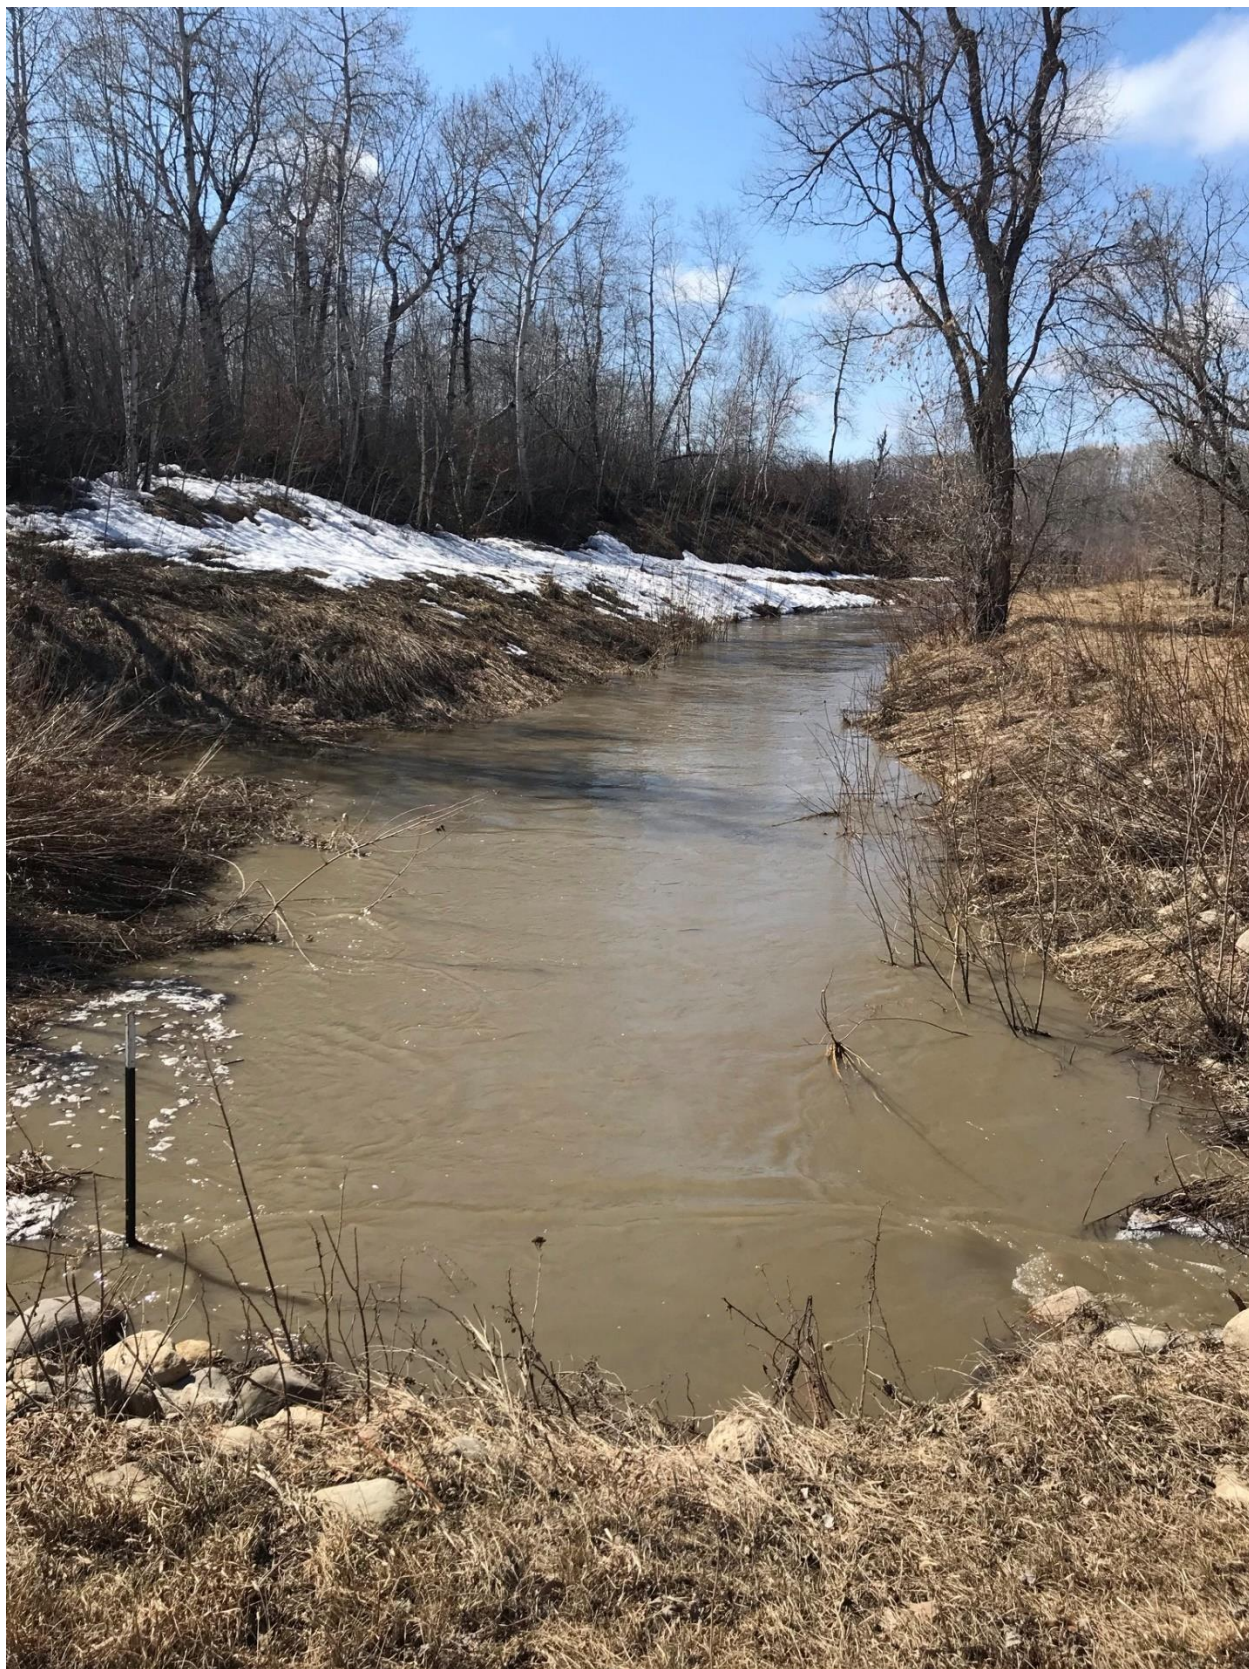
Appendix 7: Culverts not visible - a good indication that velocities are too high to allow fish passage ( $>1.5\text{m/s}$ )

Water levels at the bridge benchmark of 1.4m or higher will cause velocities of  $>1.5\text{m/s}$ . If/when this is the case, fishway managers will have to lower the gates until water levels decrease to a point where these target velocities are achieved. In this case, the SLWD velocimeter should be used. A good indication that the flow is passable if the top of the culverts are visible on the upstream side. However, use the velocimeter to confirm average velocities by taking a measurement 20cm below the surface for every 20cm of stream width in front of the culverts.

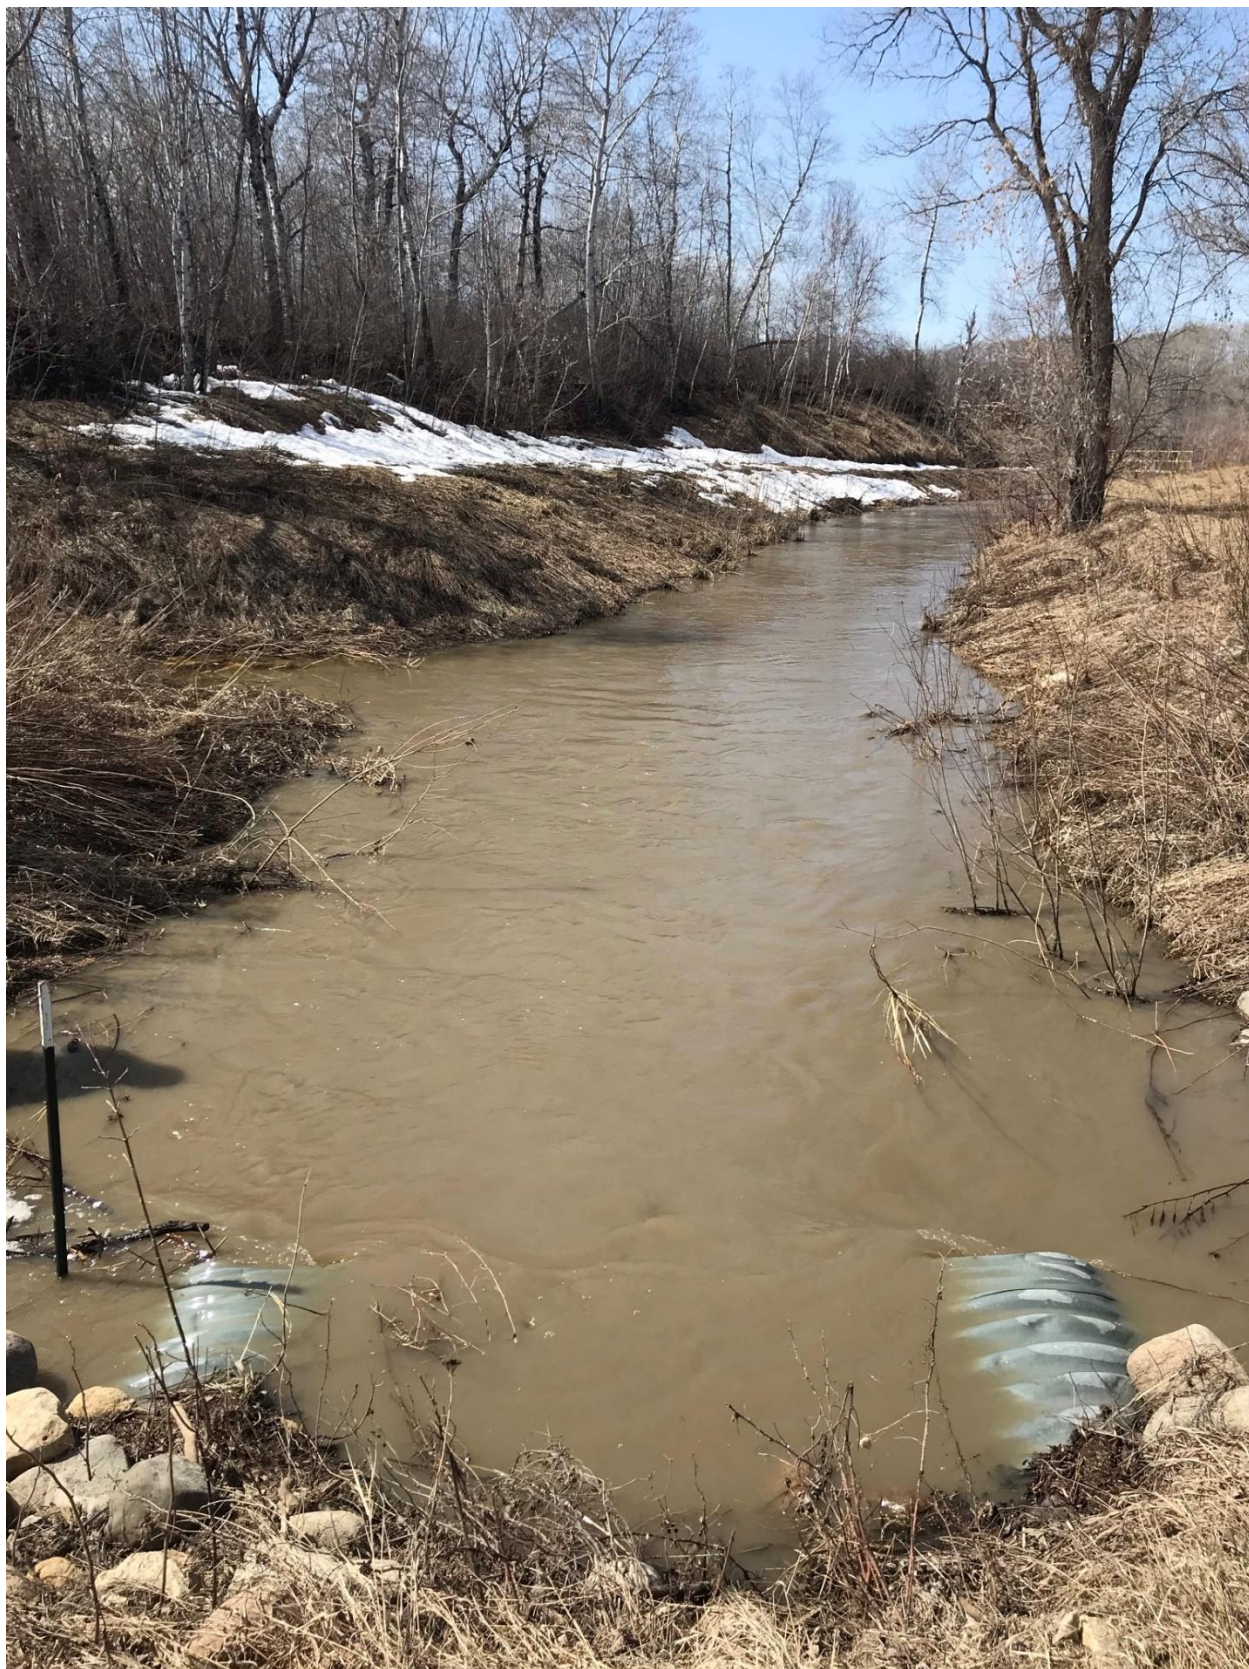
Appendix 8: Culverts visible - a good indication of water levels with velocities tolerable for fish passage ( $<1.5\text{m/s}$ )

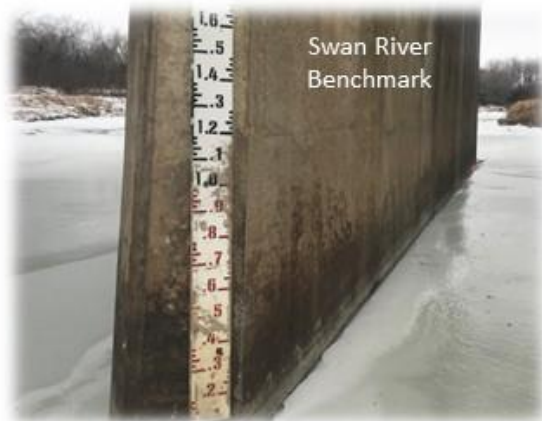
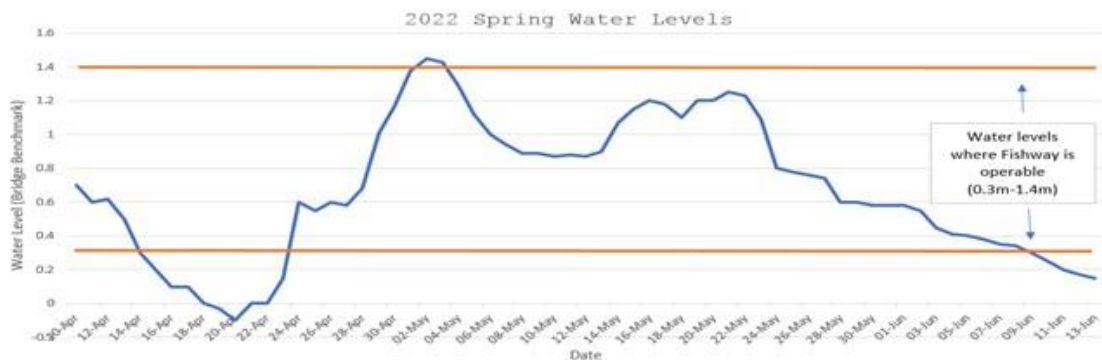
Water levels  $>1.4\text{m}$  will cause velocities through the culverts to surpass an average of  $1.5\text{m/s}$ , which is the threshold where fish are unable to overcome the culverts. In general, if the top of the culverts can be seen, velocities should be tolerable. If not, the water control structure will have to be used to decrease water levels, and associated velocities through the culverts.

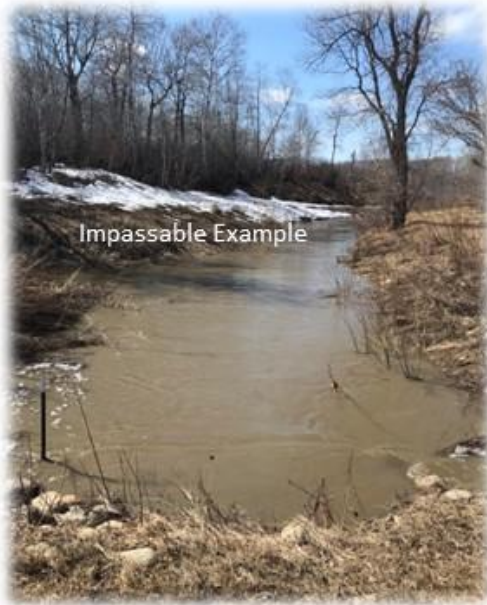
Impassable Example

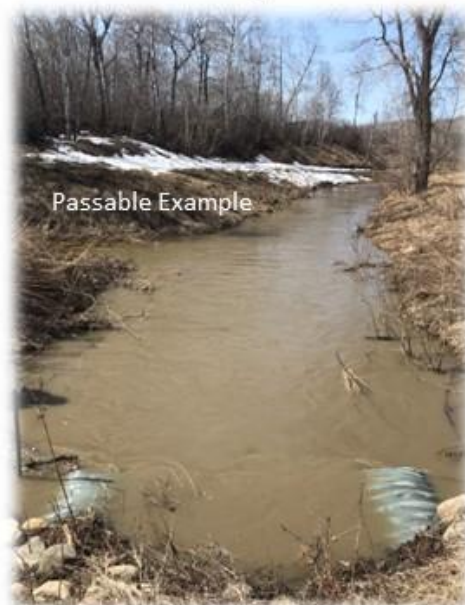
Passable Example

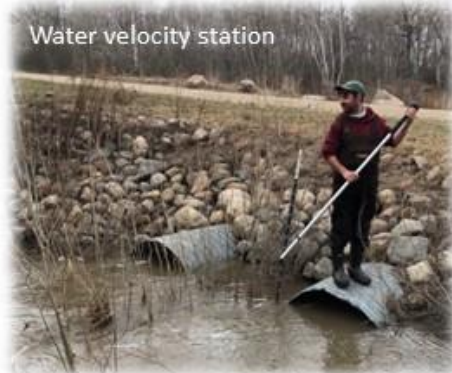
Water velocity station

To be sure water velocities are tolerable, use the Global Water Flow Probe velocimeter. Reading should be taken at 20cm depth at every 20cm of stream width in front of each culvert. This equates to 5 readings at each culvert. To ensure fish can overcome the culverts, you want average velocity to read  $<1.5\text{m/s}$ .

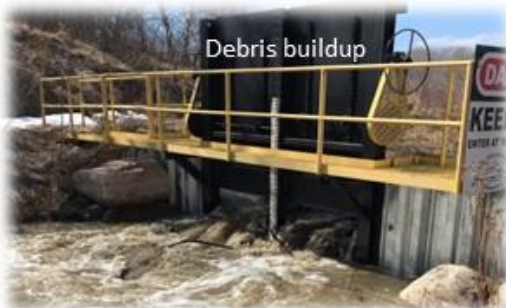
Debris buildup

Woody debris can cause issues with the fishway and may cause the water control structure to be unusable and also may cause damming if debris buildup is substantial. In order to alleviate these problems, safely remove accumulated debris at each visit to the fishway. If it is unsafe to do so, wait until water levels decrease to safe levels.

Gates on the water control structure should be left fully open at all times (to alleviate debris build-up) and should only be lowered at times or periods of high water ( $>1.4\text{m}$ )
