# 2022 Whitefish Lake Recruitment Survey

In part of reporting for FES Project 22-010  
SVSFE Initiatives and Monitoring of Recreational  
Fisheries in the Swan Valley Area

Author: Holly Urban

Swan Valley Sport  
Fishing Enhancement Inc.

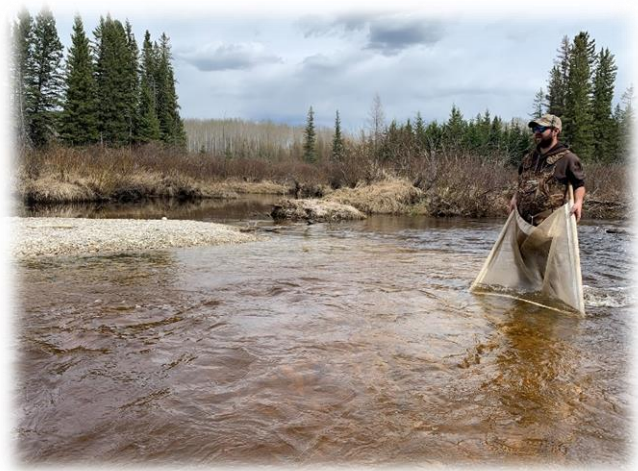
*Figure 1: Kick net*

Spawn assessments are completed through kick sampling at various sites within both tributaries. The kick netting technique involves placing the net poles firmly on the creek bottom and disturbing the substrate by “kicking” the substrate upstream of the net. The kick net used is a 1 m<sup>2</sup> net with 0.5 mm (500 micron) mesh screening attached to two poles (Figure 1).

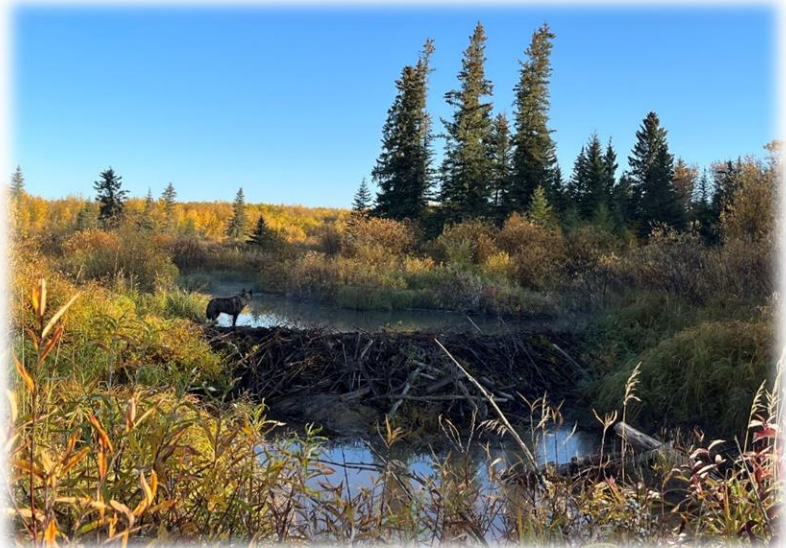
*Figure 2: Inventory of North Creek barriers*

Inventory of barriers is typically conducted in the fall by travelling upstream creeks by boat and then by foot when boat access is restricted. Technicians flag each barrier and document; coordinates, barrier width, height, dam material plus take reference photos. All information is provided in digital and paper format for future reference while dam blasting occurs.

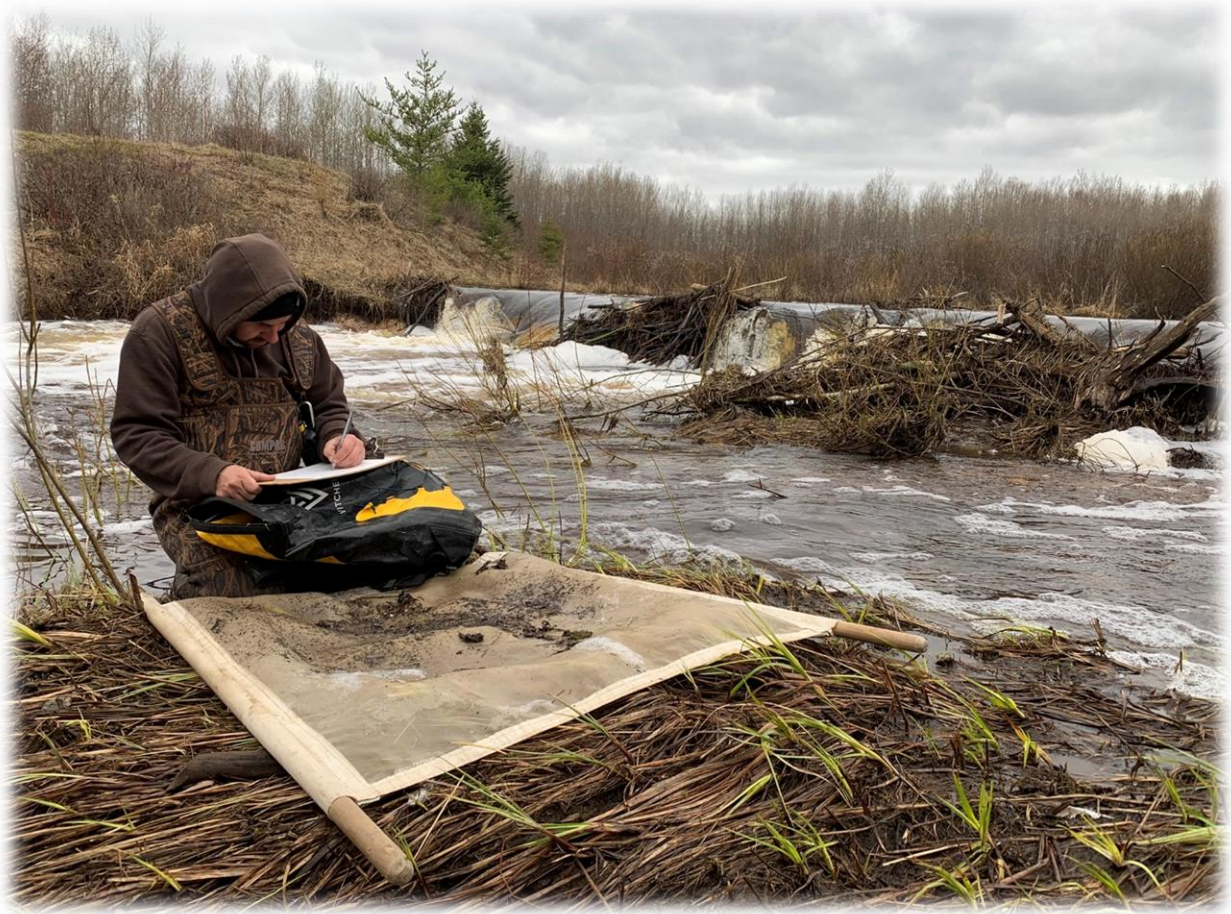
On May 17<sup>th</sup> technicians travelled to Whitefish Lake with the intentions to conduct kick sampling surveys. Upon investigations, it was quickly determined fish were actively spawning therefore assessments would have to be postponed a few days. During this time barriers were found to be reconstructed following dam blasting efforts. It is important to note on Friday, May 13<sup>th</sup>, "communities near of the Porcupine Hills and Duck Mountain endured unprecedented flash-flooding conditions as a Colorado low stormwater poured down the Manitoba Escarpment" (Kives 2022). With the combination of heavy winter snow levels melting and heavy rains, flooding incapacitated travel to many areas, and increased velocity and discharge levels significantly. These conditions caused changes in several reaches of both North and Lagoon creek, exposing vital spawning habitat, clearing many obstructions, and changing the creek course in some areas.

Figure 3: Barrier on North Creek that was removed following extreme rainfall

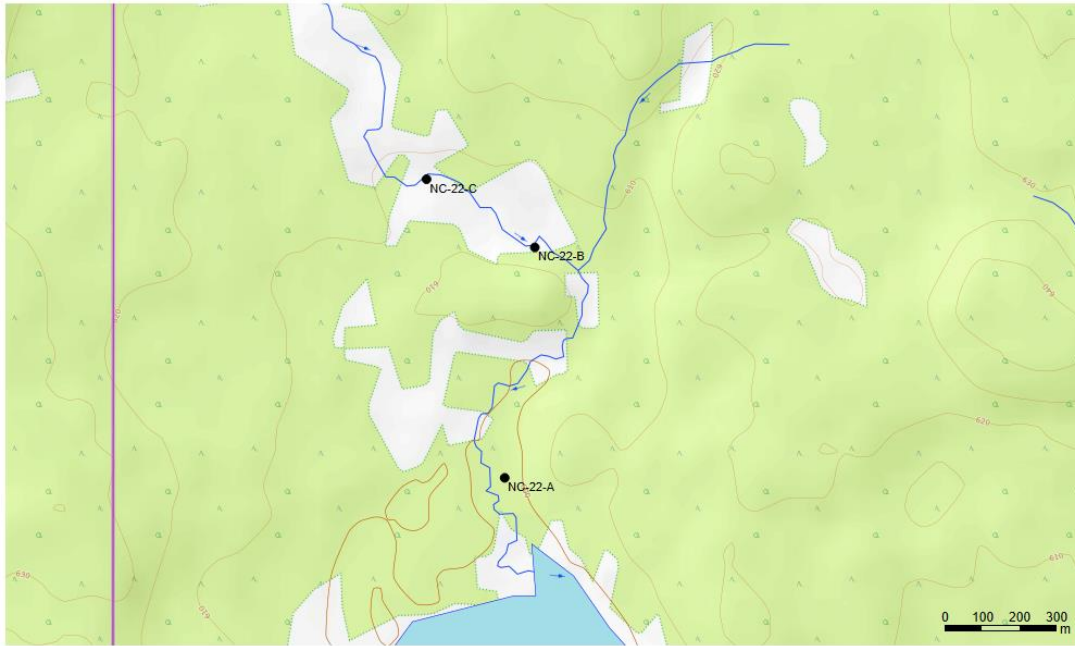
Figure 6: North Creek barrier found in 2022

On September 29<sup>th</sup>, 2022 barriers on North Creek and Lagoon Creek were identified and marked. Only three priority dams were identified for removal on North Creek, while seven barriers were identified on Lagoon Creek. This is the lowest number of barriers recorded on North Creek since beaver management began in 2011.

In summary, the 2022 beaver management program was able to enhance several reaches of both Lagoon and North Creek thanks to an extra boost from mother nature. Barrier removals are scheduled for early April 2023, and spawn assessments are anticipated in mid-May. There has been no further correspondence with the local trapper as current efforts appear to be adequate. Throughout the past twelve years SVSFE has monitored the fishery and actively maintained vital spawning habitat. Angler reports express these efforts are valuable and angling success has been outstanding. SVSFE intends to continue with annual recruitment surveys and management of fish barriers on this self-sustaining fishery for years to come.
