Summary of Activities

Date: July 28, 2016

Subject: Chain Lakes - Bathmetry & Water Level Investigations

Location: Chain Lakes, Duck Mountains, MB - 14 U 368079 5726194

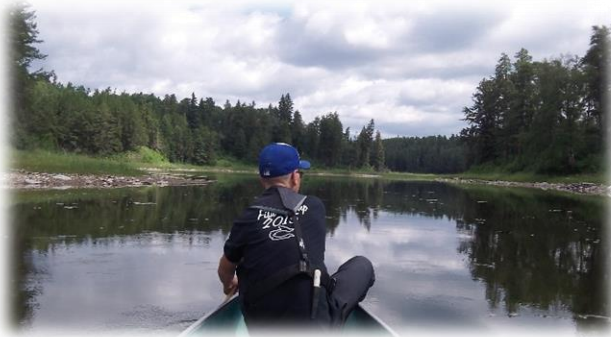
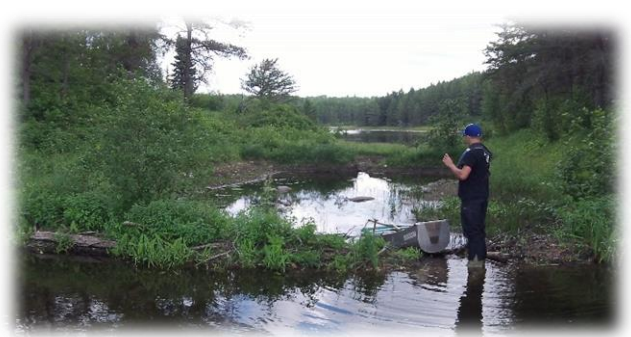
Recommendations: Due to observations and information collected on July 16th, it is without a doubt that the lake levels are significantly lower, and the root cause of this has been identified. A large dam on the far north of the "chains" has blown and as a result dropped water levels significantly (especially in the lower reaches ~2m). After discussions with local, and common Chain Lakes anglers we have determined that this drop in water levels likely occurred at some point between 2014 and 2015. At this point in time, we see no immediate need for dam rehabilitation, as it appears that each reach of the chain lake system currently possesses enough depth to support northern pike populations. However, if it becomes necessary to initiate dam rehabilitation in the future, the route cause has been identified.
